Water Quality Report for Selected Lakes and Streams

Leon County Public Works
Division of Engineering Services

November 2024
(Water Quality Data collected through December of 2023)

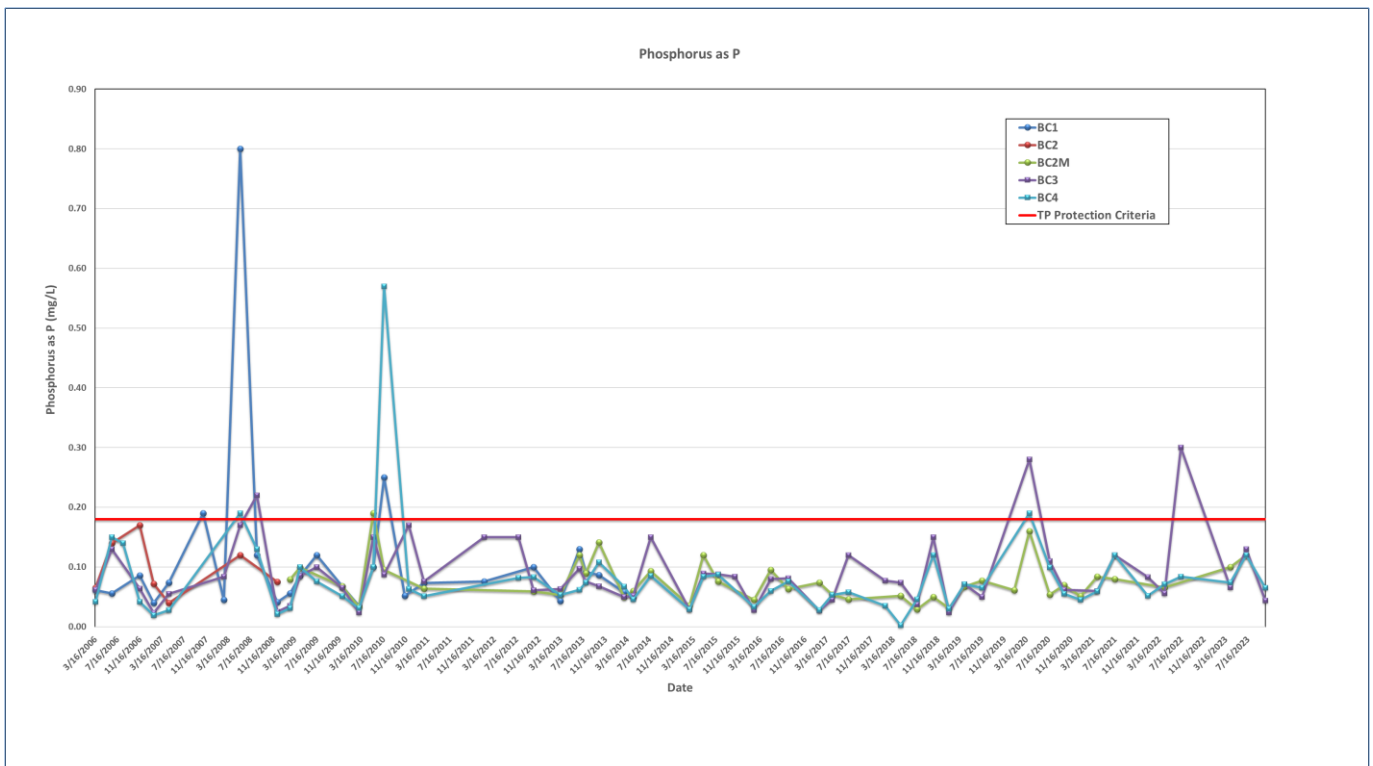
Figure 2. Total phosphorus results for Northeast Black Creek.

The nutrient thresholds and results are found in **Tables 1 and 2**. The NNC has never been exceeded during the period of record.

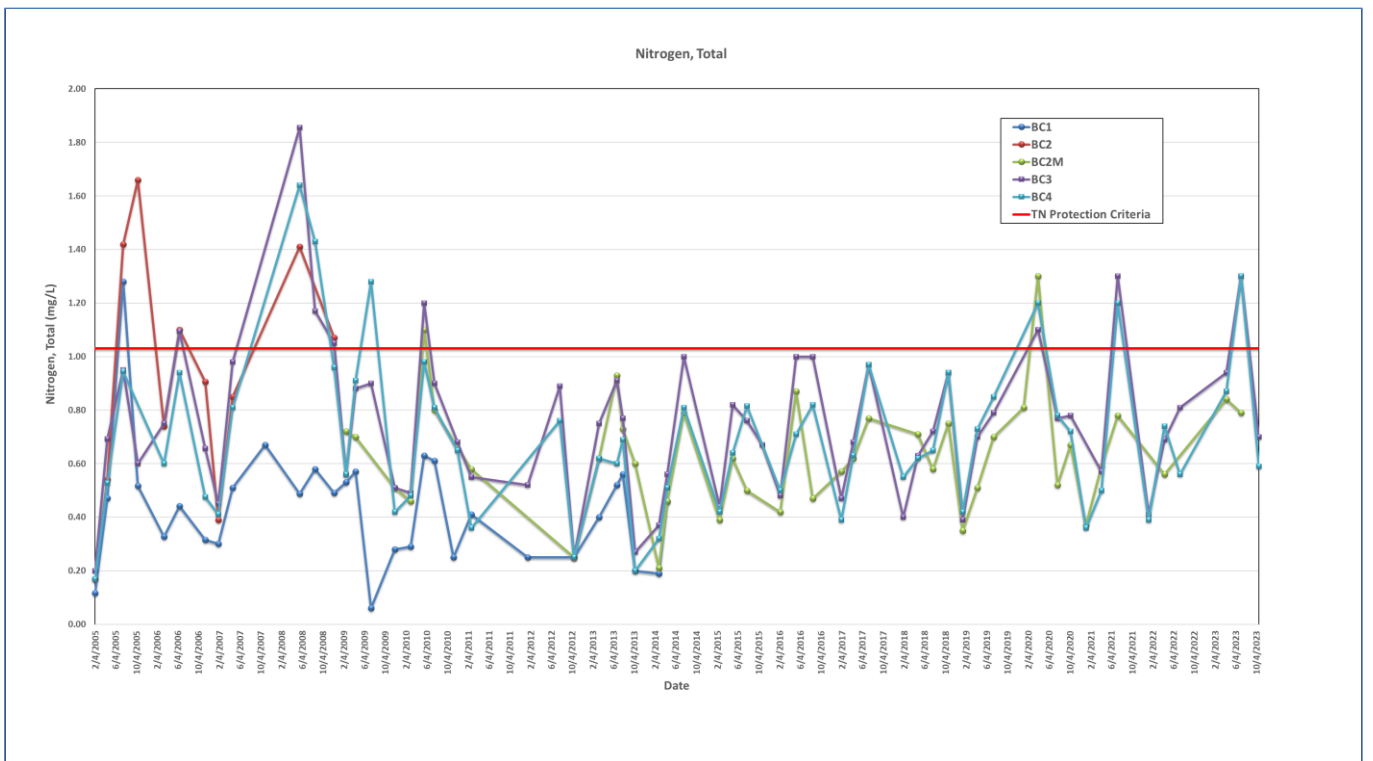
Figure 3. Total nitrogen results for Northeast Black Creek.

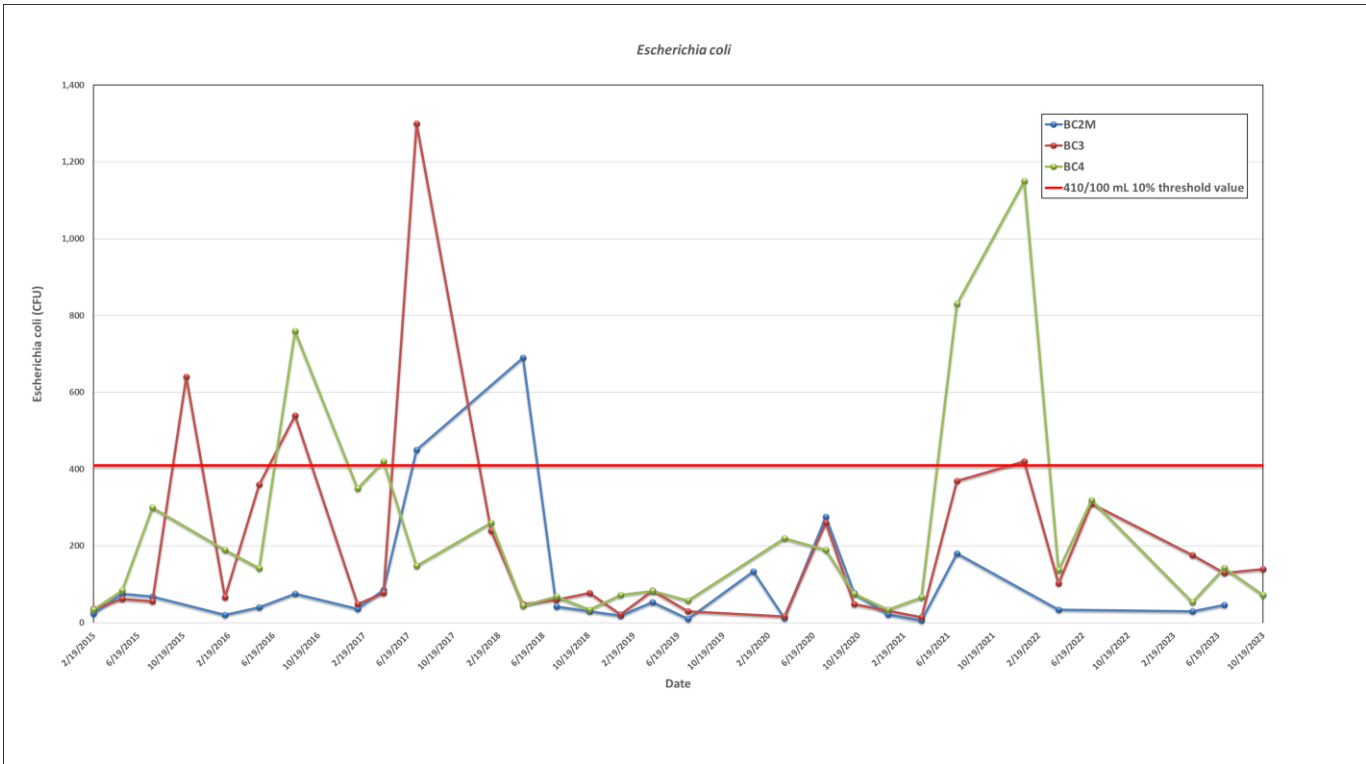
Figure 4. *E. coli* results for Northeast Black Creek.

The *E. coli* water quality limit of > 410 in 10% of samples collected over a thirty-day period was exceeded several times at stations BC2M, BC3 and BC4 (**Figure 4**). Based on anthropogenic land use, FDEP considers the exceedances possibly the result of residential development in the watershed (e.g., improperly functioning septic tanks). Other causes could be wild animals and/or agriculture.

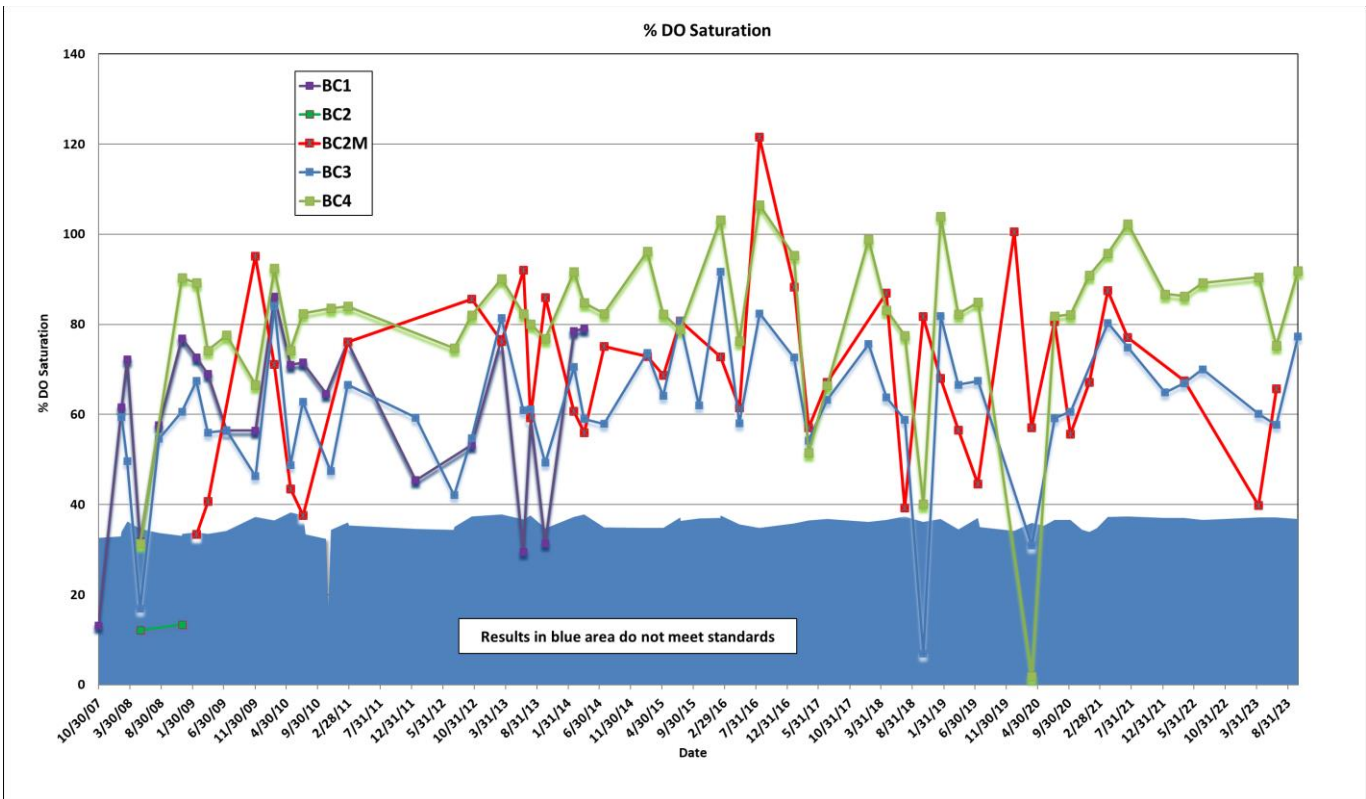
Figure 5. Dissolved Oxygen Percent Saturation results for Northeast Black Creek.

As **Figure 5** shows, Northeast Black Creek stations occasionally did not meet the Class III criteria for dissolved oxygen (DO). Staff believes that this is a natural condition for this location, since the creek is a low gradient blackwater stream that drains wetlands.

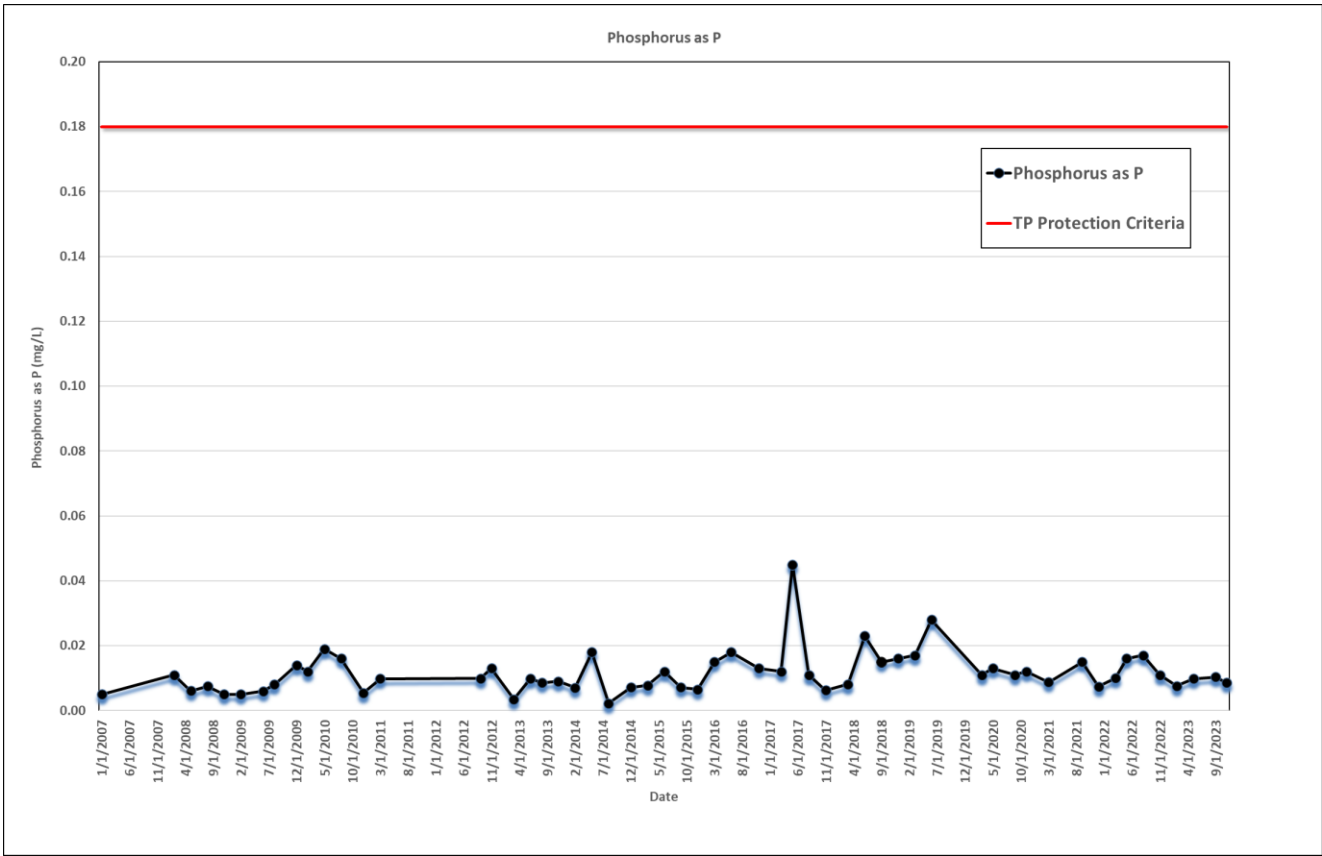
Figure 2. Total phosphorus results for Fisher Creek.

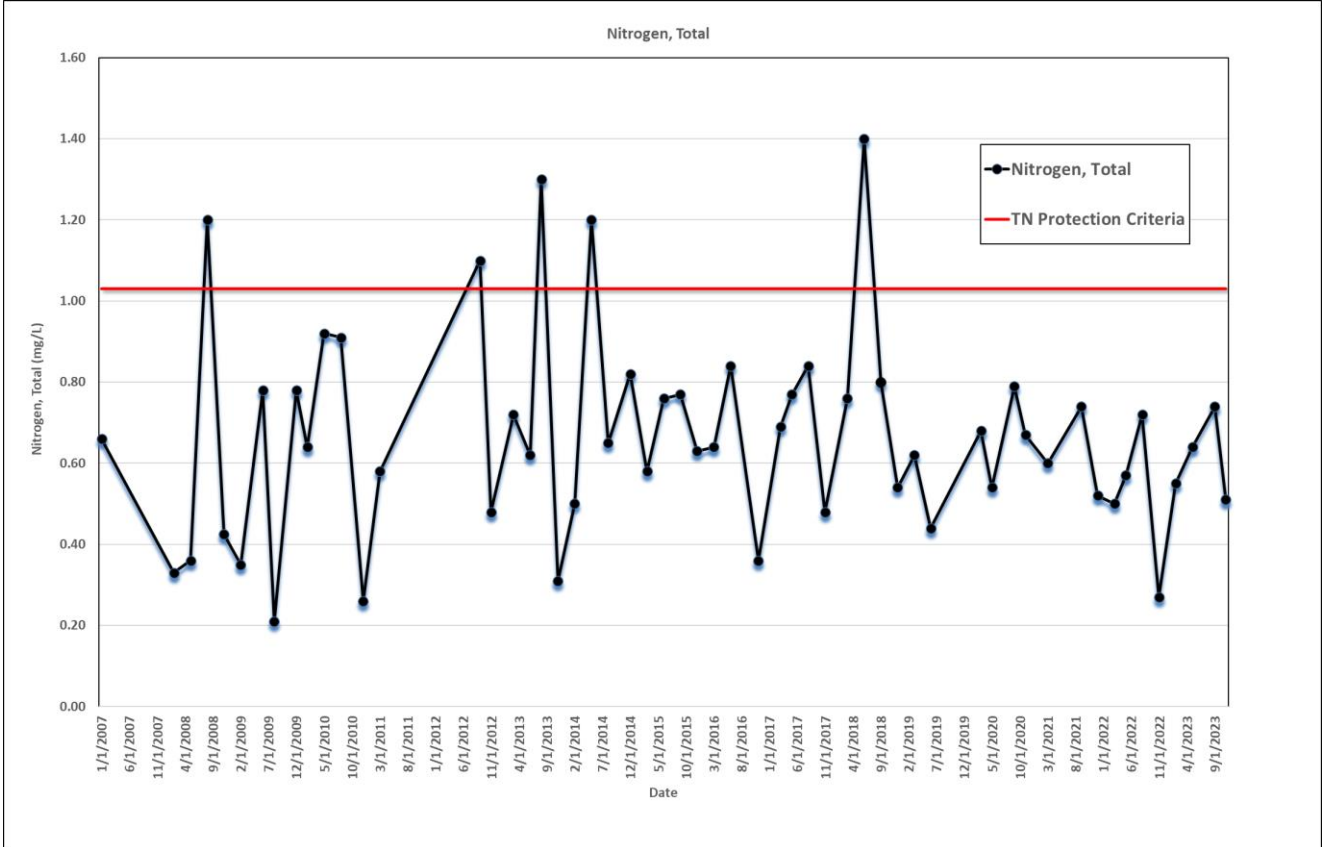
Figure 3. Total nitrogen results for Fisher Creek.

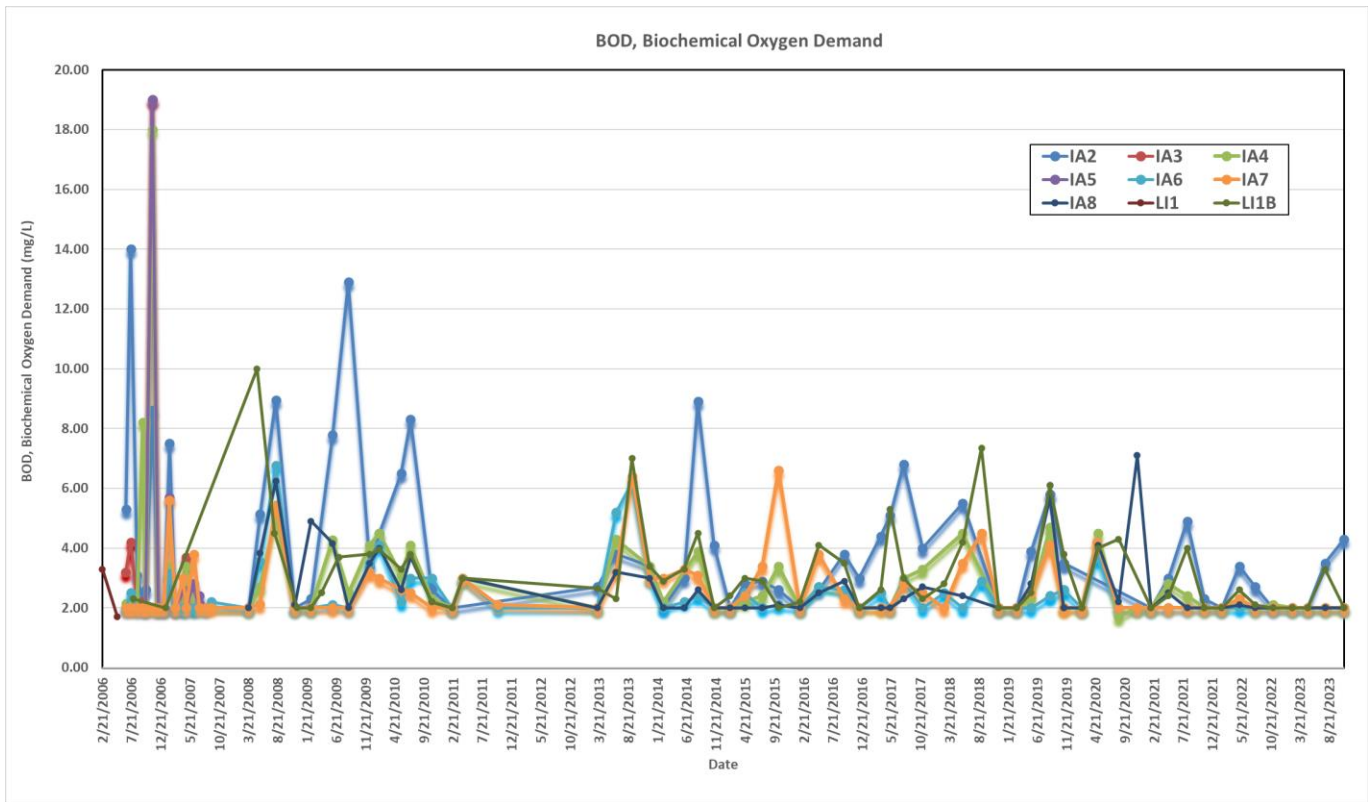
Figure 3. Biochemical Oxygen Demand (BOD) results for Lake Iamonia.

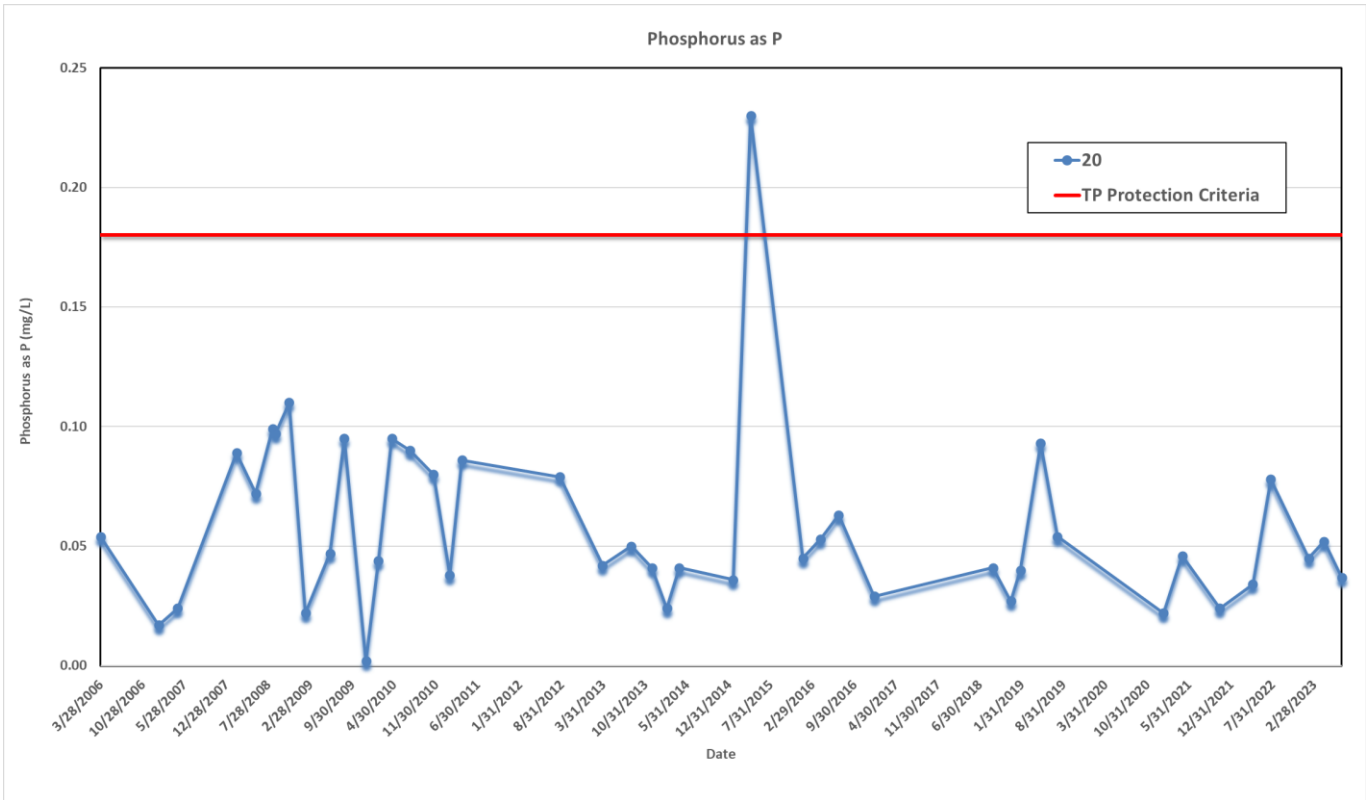
Figure 1. Total Phosphorus results for Plantation Stream.

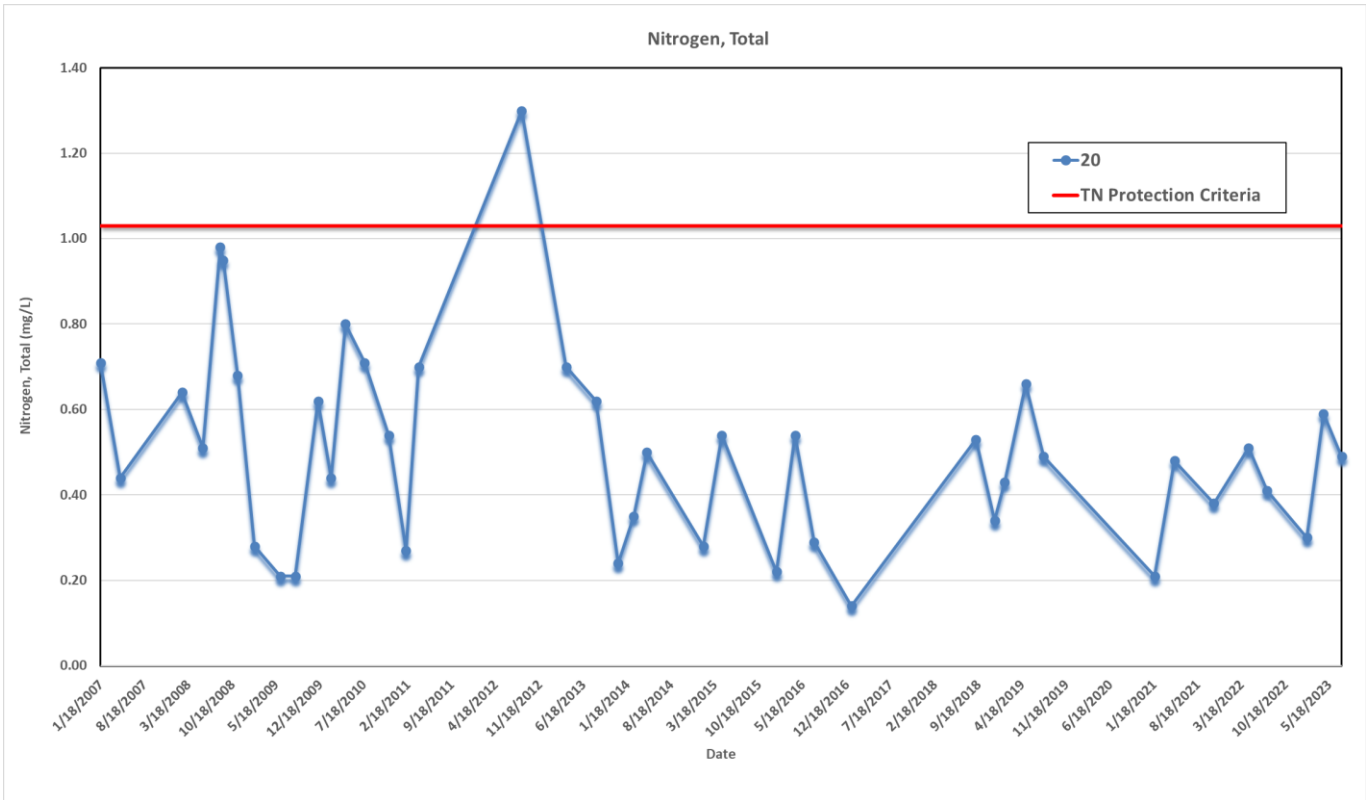
Figure 2. Total Nitrogen results for Plantation Stream.

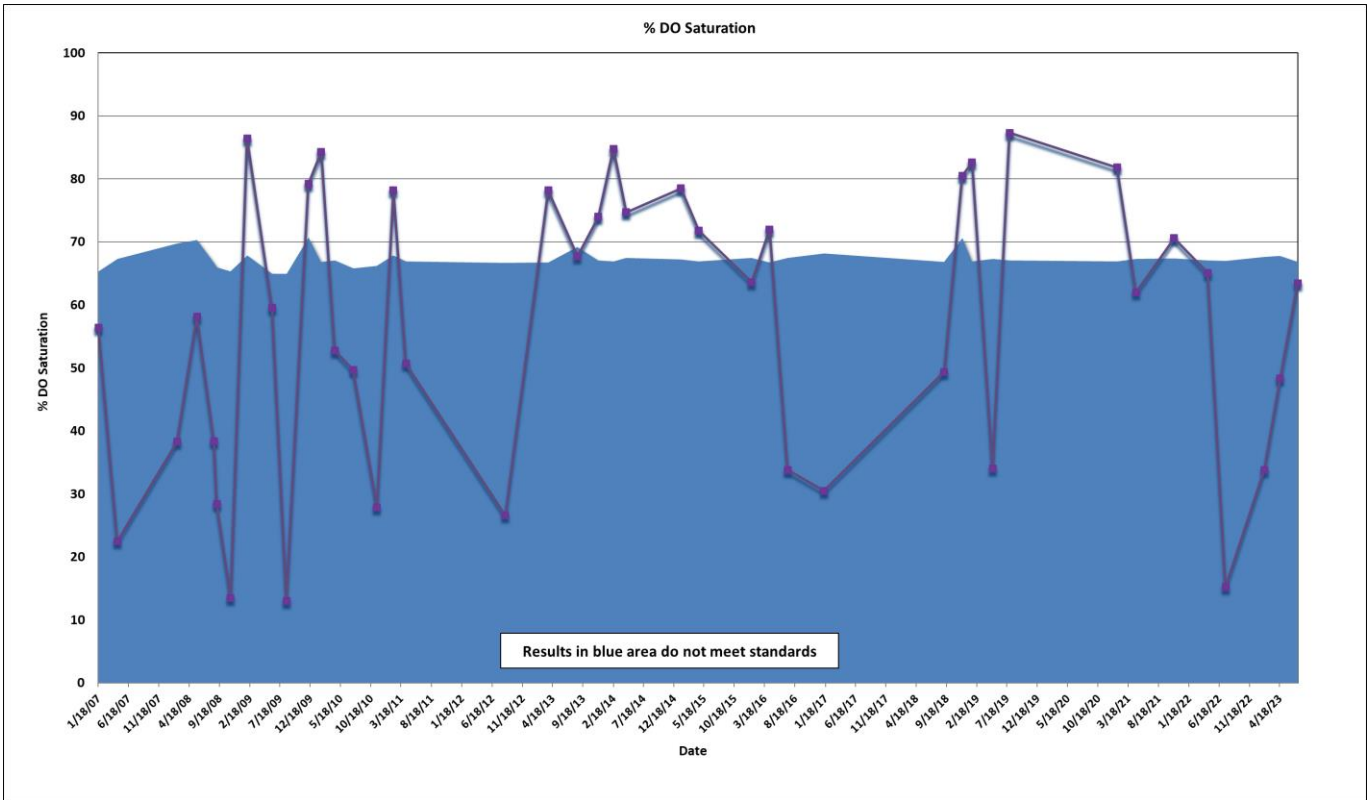
Figure 3. Dissolved Oxygen Percent Saturation results for Plantation Stream.

Based on the samples collected, Plantation Stream appeared to meet the nutrient thresholds for the Big Bend Bioregion. While DO results did not always meet Class III water quality standards, low gradient low flow streams normally have lower DO values which, in this case, were further exacerbated by input from the adjacent wetland. Other water quality parameters appear to be normal for the area and no impairments were noted.

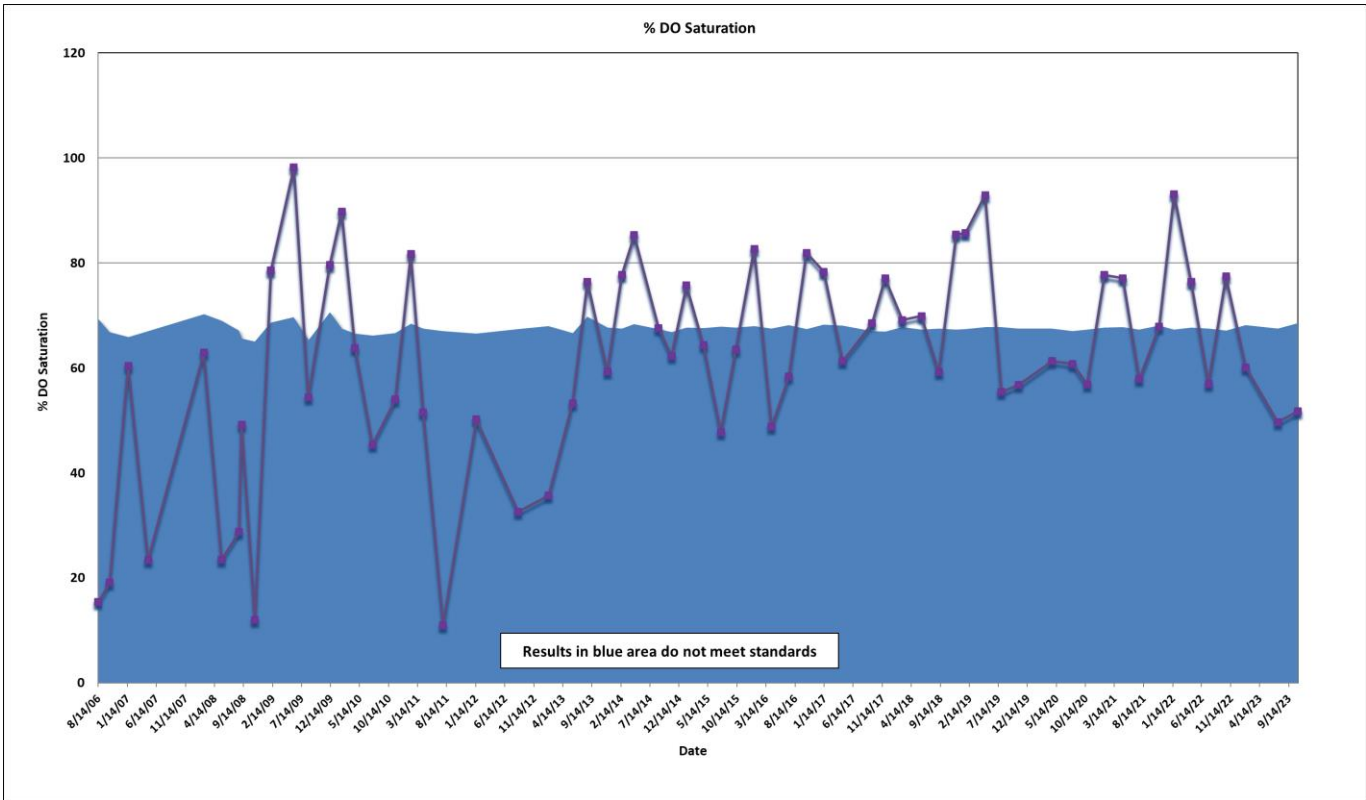
Figure 2. Dissolved Oxygen Percent Saturation results for Tall Timbers Creek.

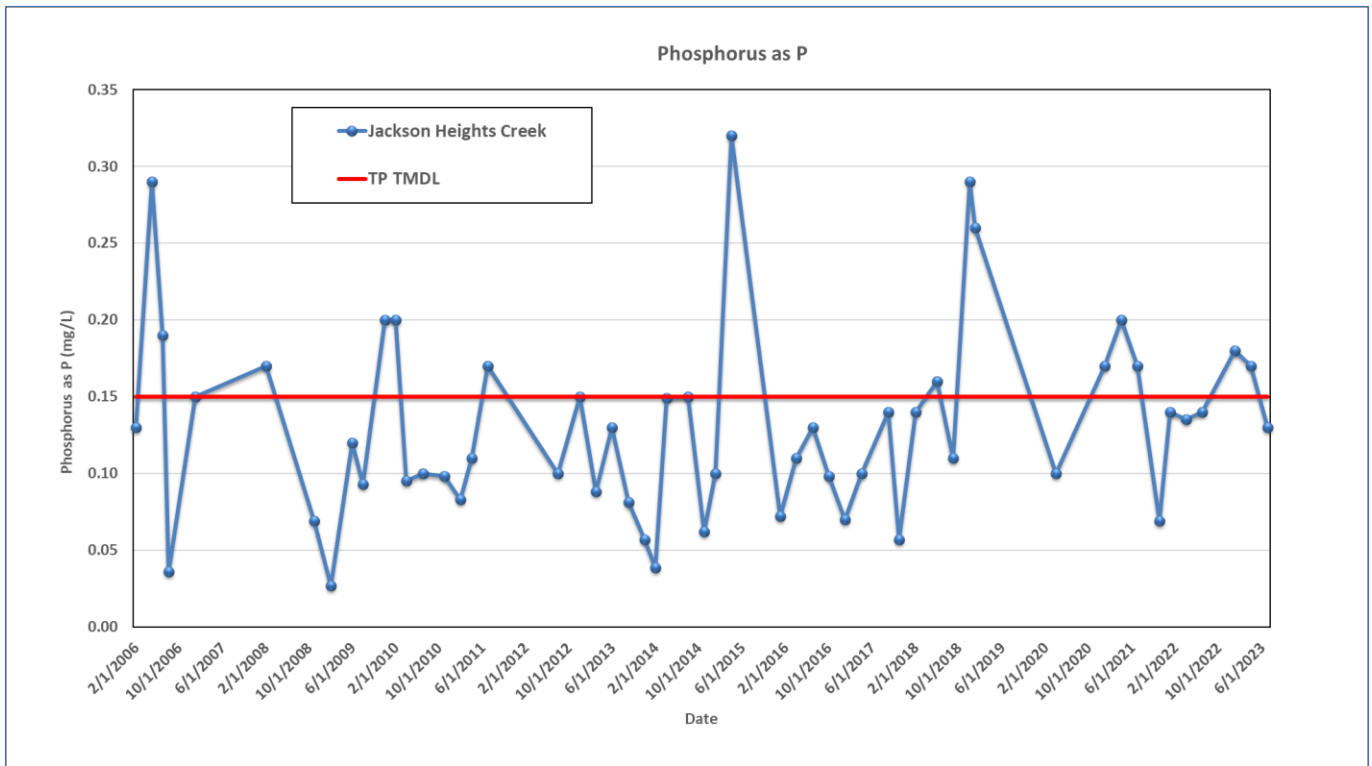
Figure 2. Total Phosphorus results for Jackson Heights Creek.

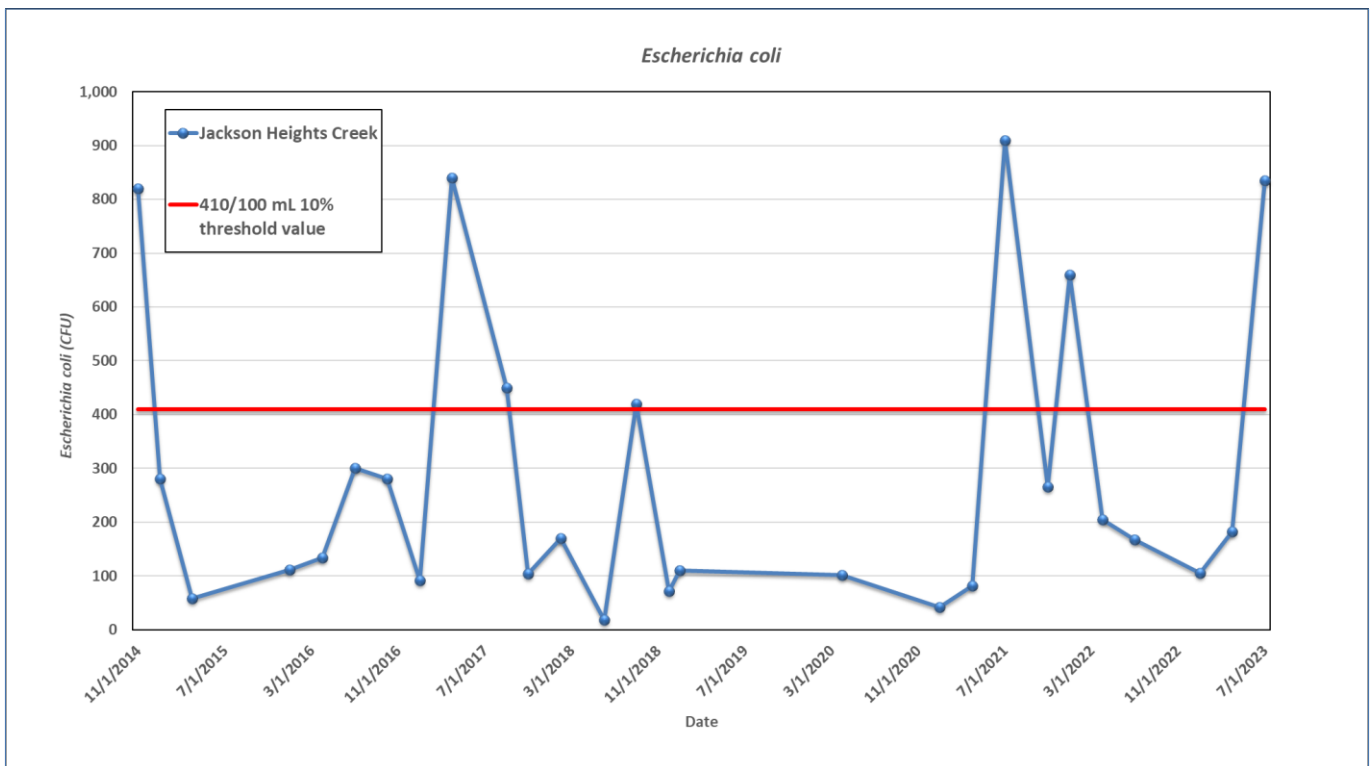
Figure 3. *E. coli* results for Jackson Heights Creek.

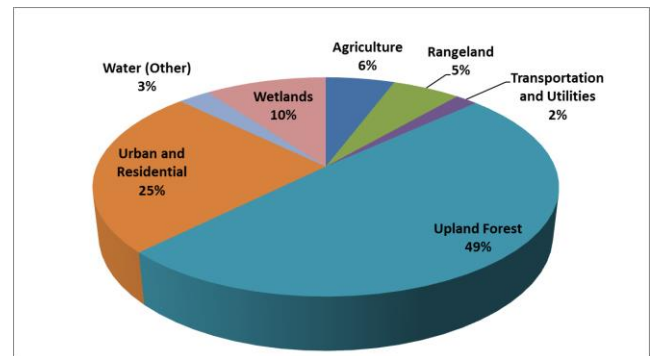
Figure 1. Lake Carr watershed land use.

As shown in **Figure 1**, 38% of land uses in the 5,931-acre Lake Carr watershed are agriculture, rangeland, transportation, utilities, urban and residential. These types of land uses are often attributed to increases in stormwater runoff and higher nutrient loads. The lake receives direct runoff from the surrounding agricultural property as well as flow from the residential areas east of Meridian Road (Summerbrooke and Ox Bottom Manor). Waterbodies in the residential areas are modified farm ponds serving as stormwater facilities dedicated to the respective homeowner's associations for maintenance. The Summerbrooke Golf Club (157 acres) also lies in this watershed.

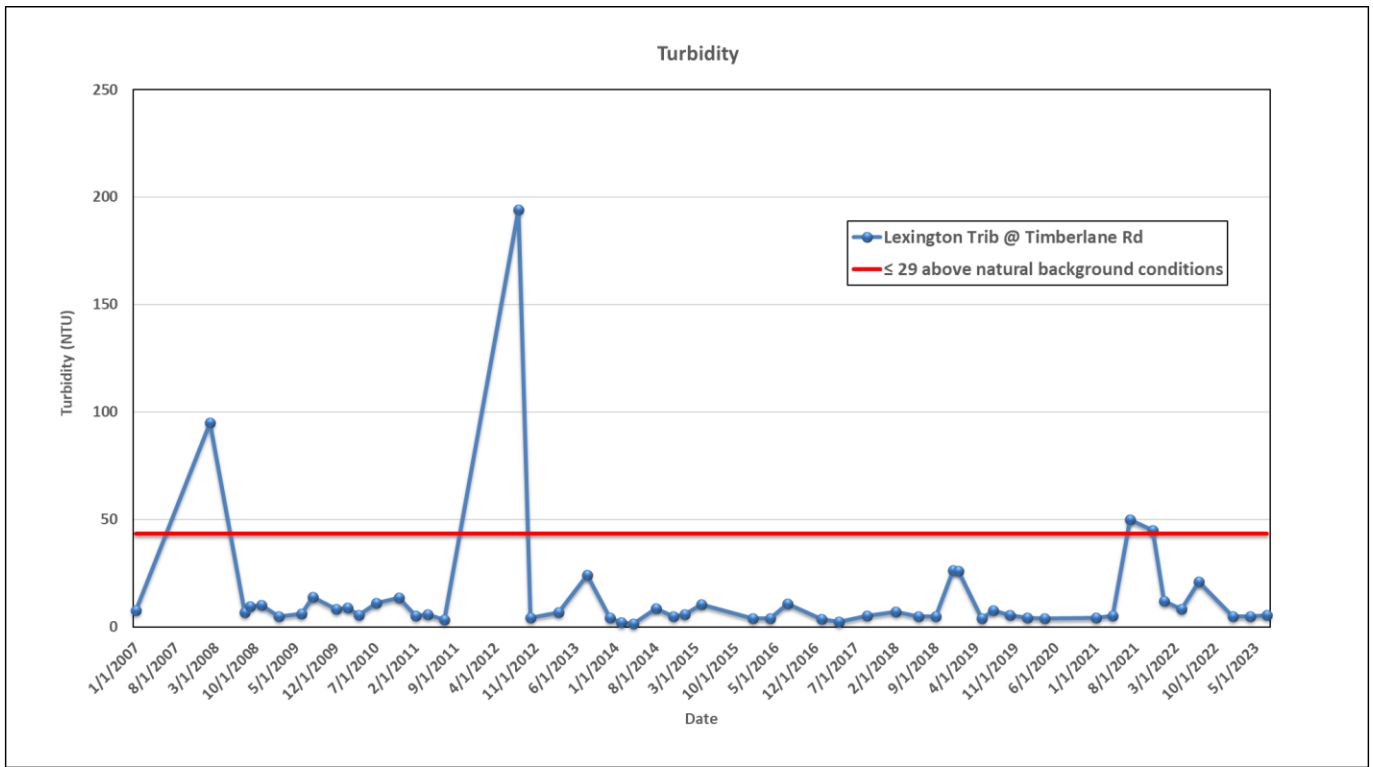
Figure 5. Turbidity values in Lexington Creek.

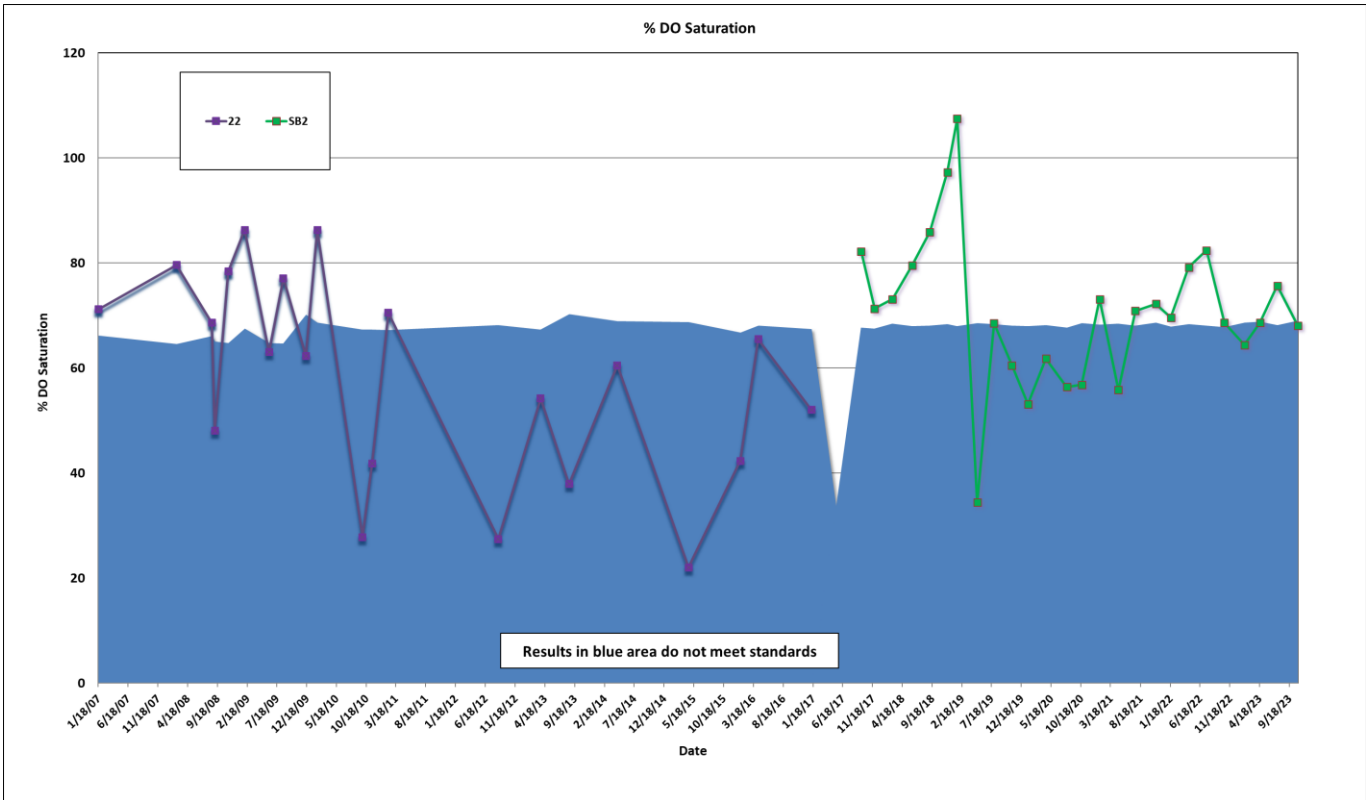
Figure 2. Dissolved Oxygen Percent Saturation results for Summer Creek.

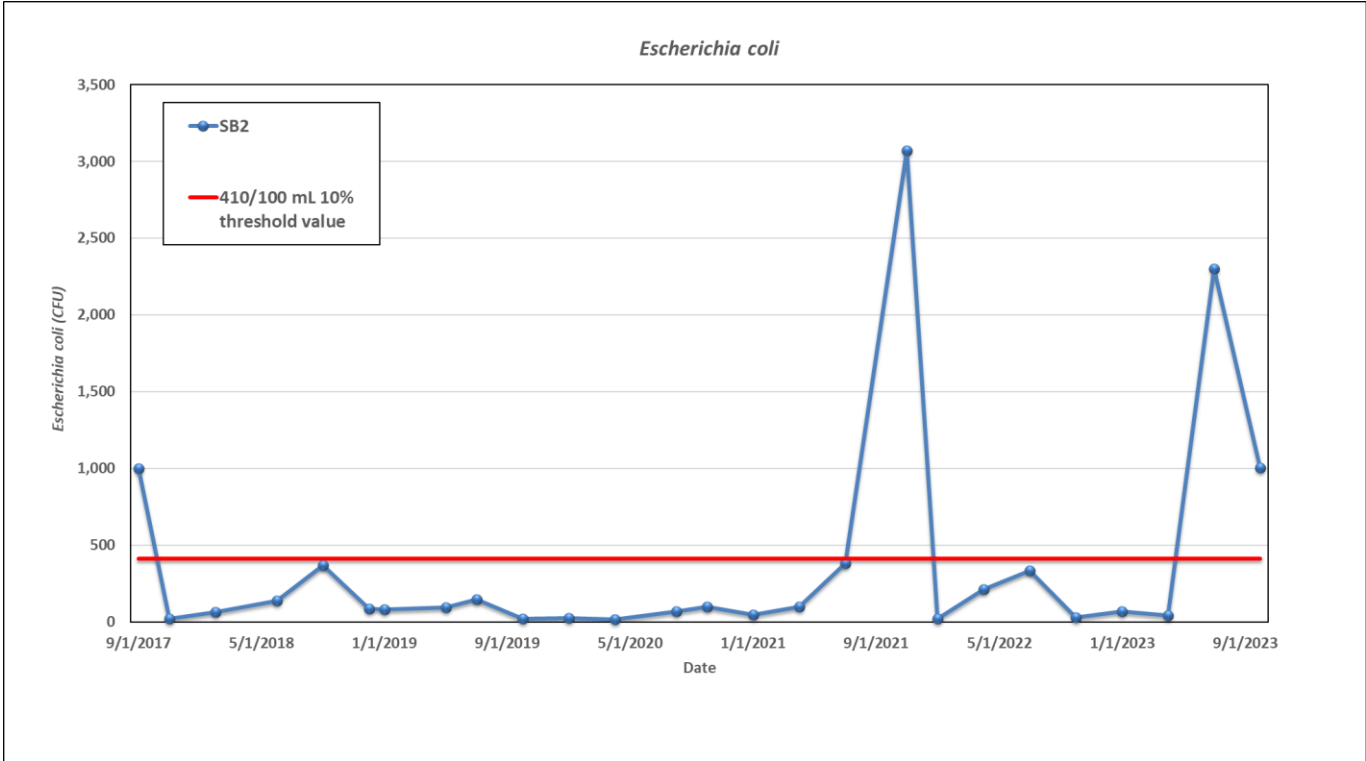
Figure 2. *E. coli* results for Summer Creek.

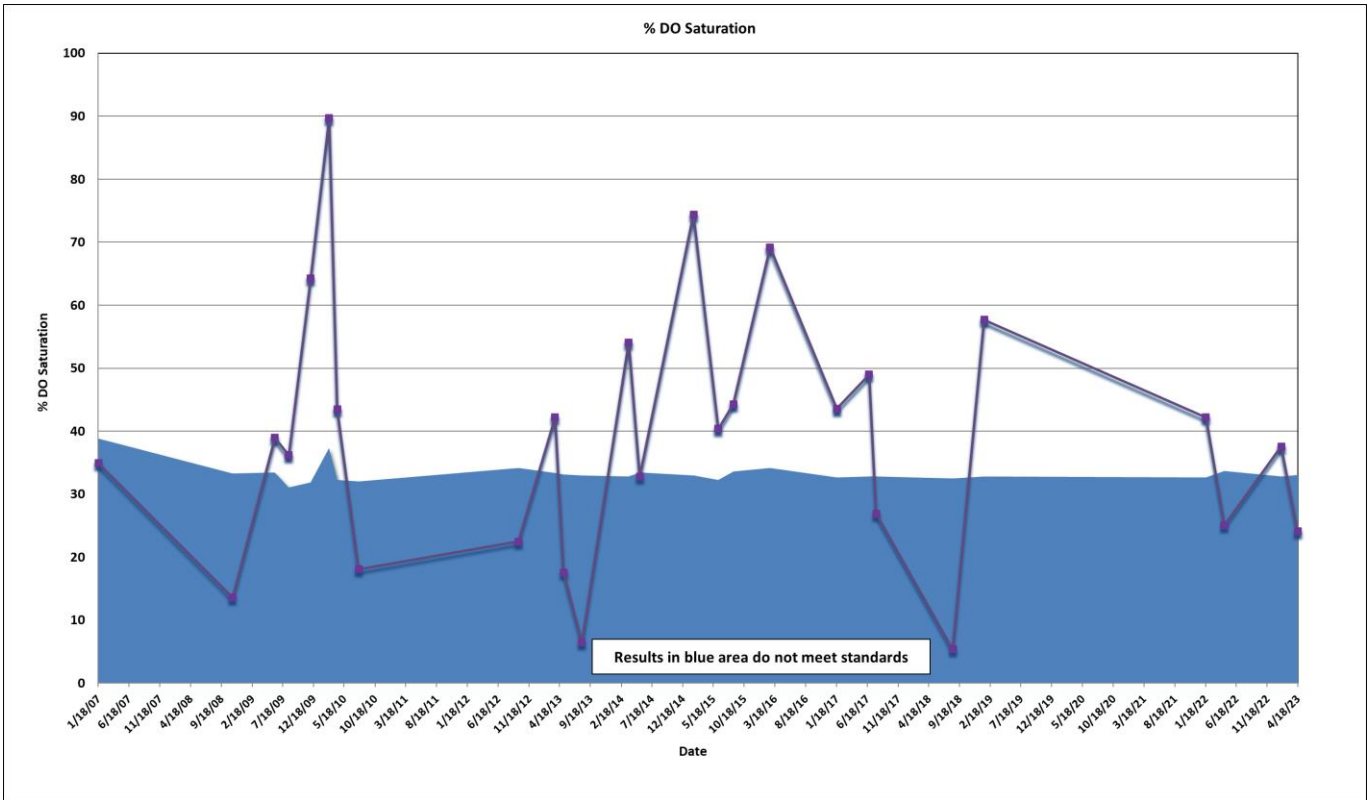
Figure 4. Dissolved Oxygen Percent Saturation results for Alford Arm Creek.

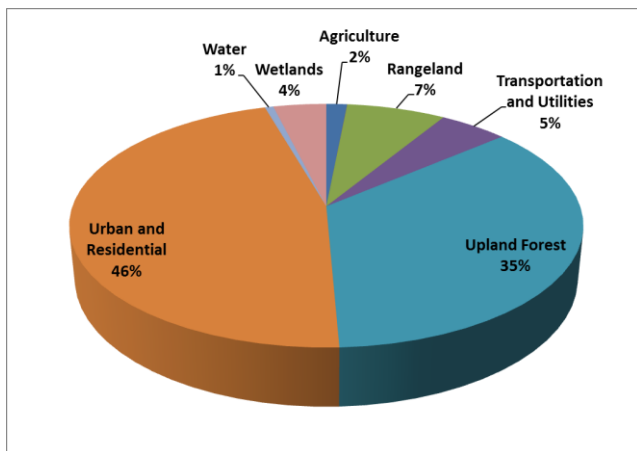
Figure 1. Lafayette Creek watershed land use.

Approximately 60% of land use acreage in the 1,860-acre watershed is agriculture, rangeland, transportation, utilities, urban and residential (as shown in **Figure 1**). These types of land uses are often attributed to increases in stormwater runoff and higher nutrient loads.

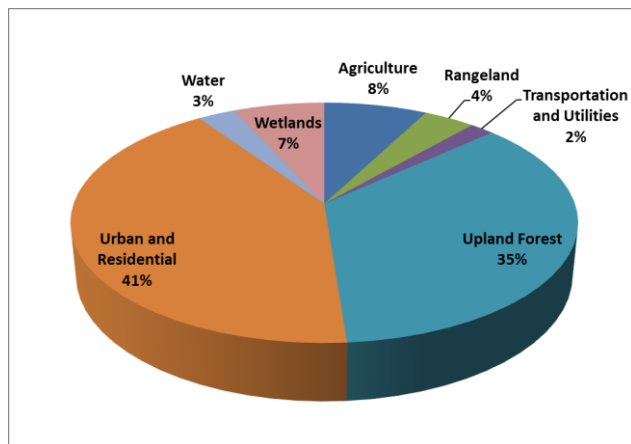
Figure 7. Alford Arm watershed land use.

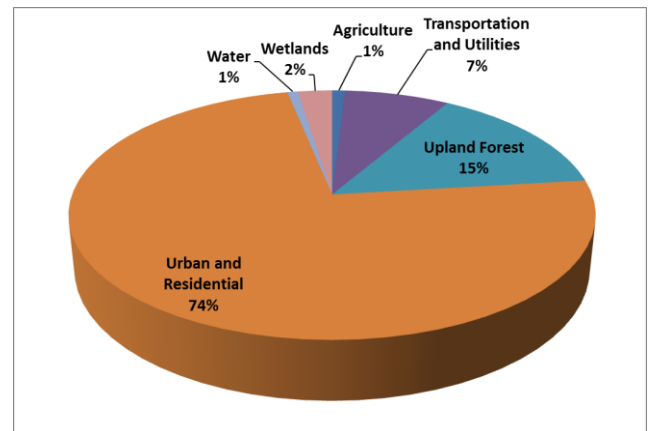
Figure 1. Northeast Drainage Ditch watershed land use.

Approximately 82% of land use in the 7,851-acre NEDD watershed upstream of the sample station is agriculture, transportation, utilities, urban and residential (as shown in **Figure 1**). These types of land uses are often attributed to increases in stormwater runoff and higher nutrient loads.

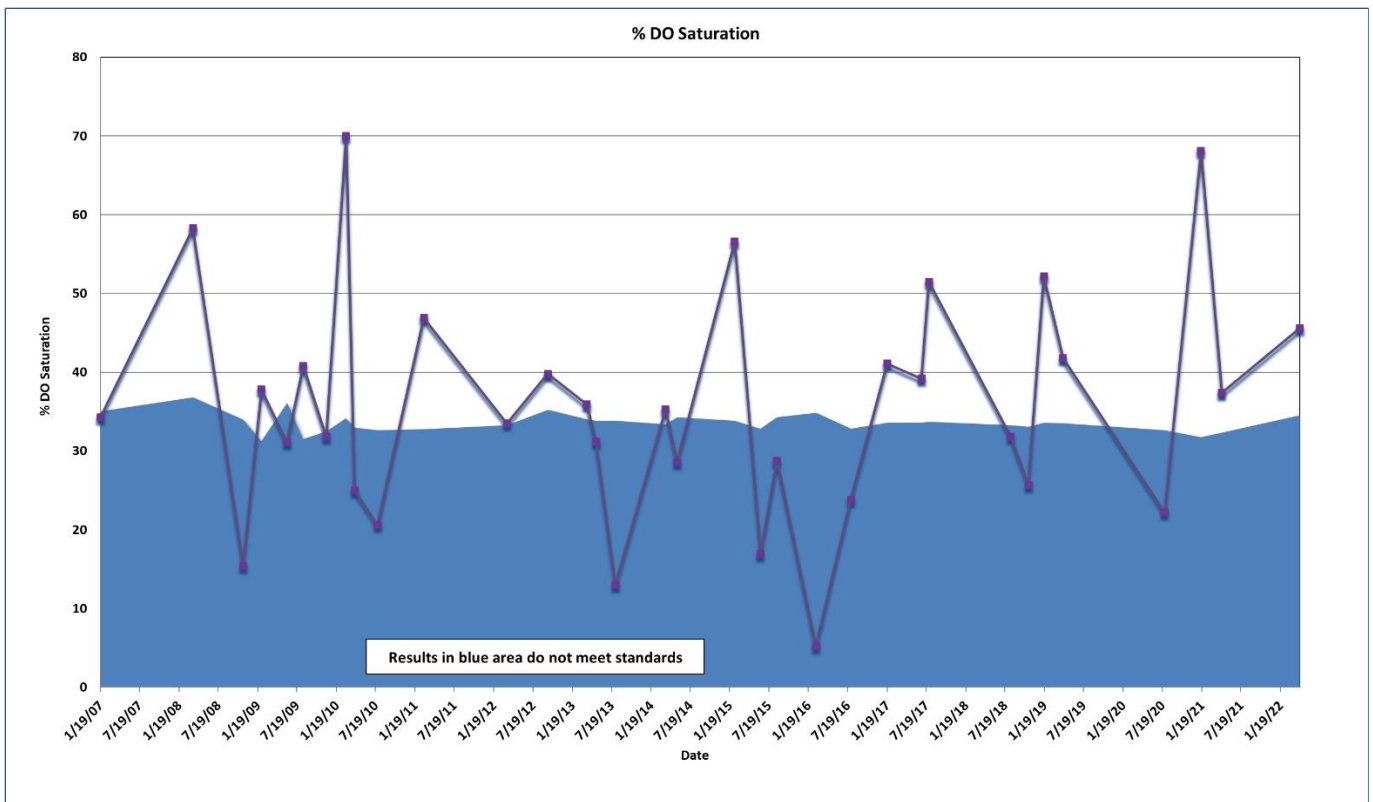
Figure 4. Dissolved Oxygen Percent Saturation results for Unnamed Stream at Chaires Crossroad.

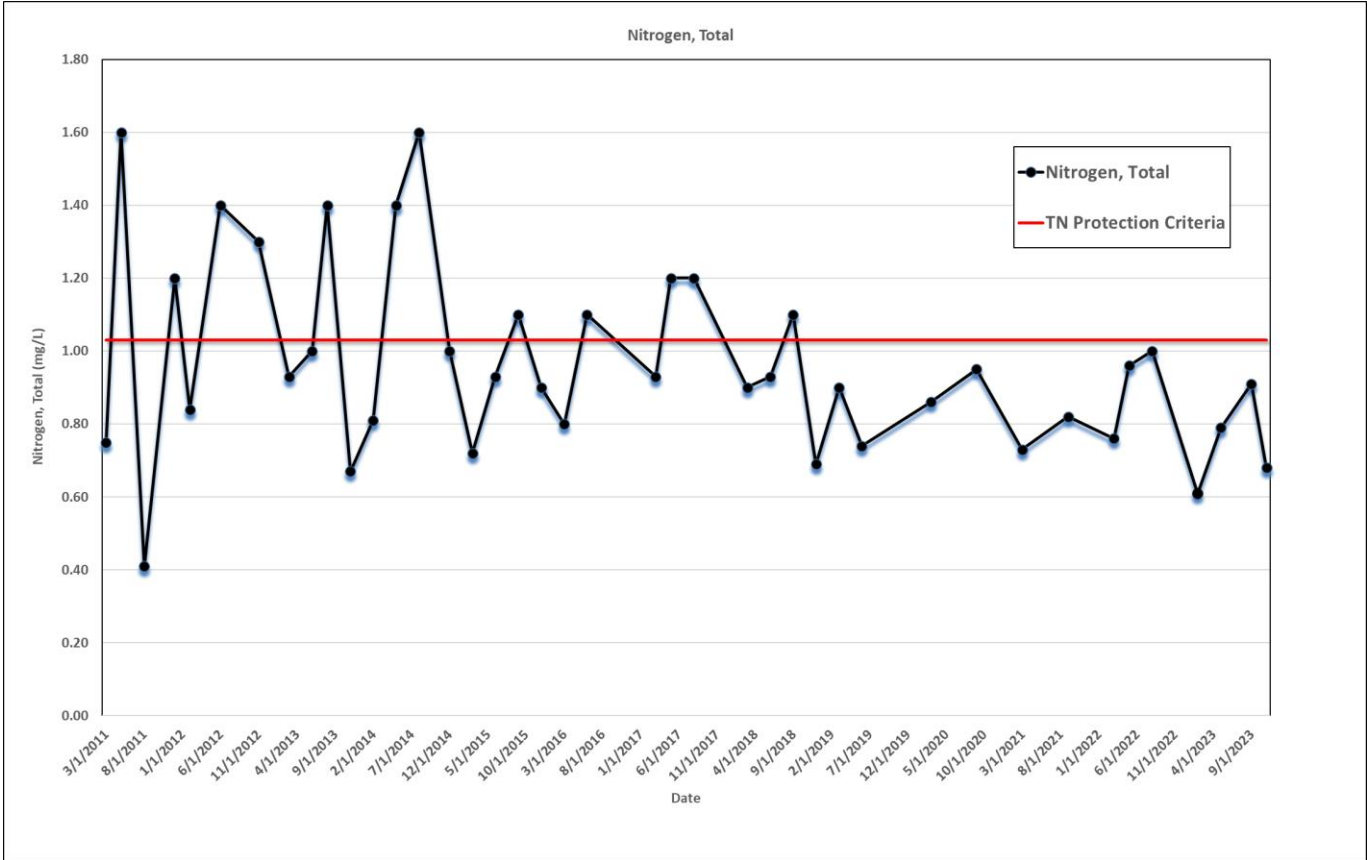
Figure 2. Total Nitrogen results for Lost Creek.
