Water Quality Report for Selected Lakes and Streams

Leon County Public Works
Division of Engineering Services

November 2024
(Water Quality Data collected through December of 2023)

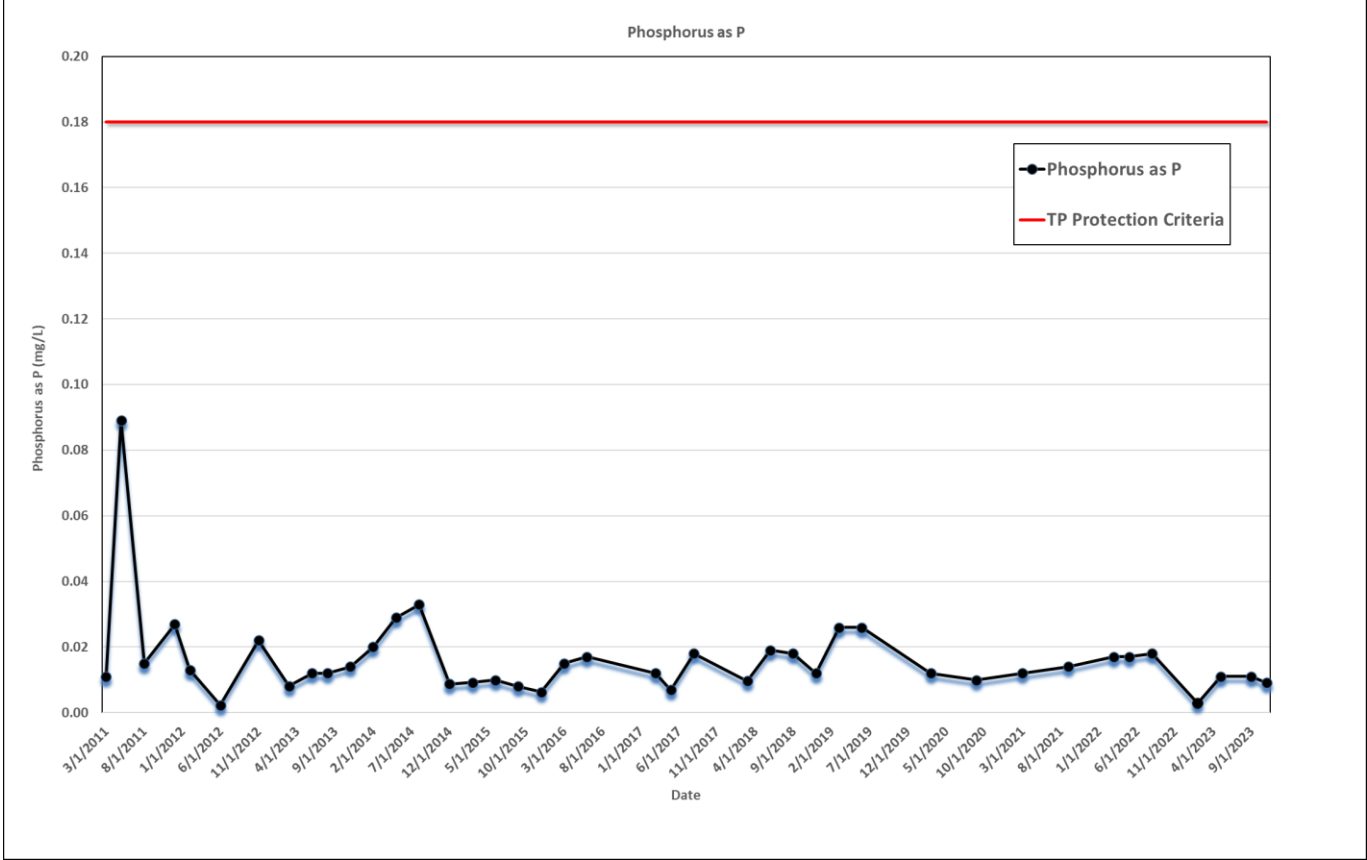
Figure 3. Total Phosphorus results for Lost Creek.

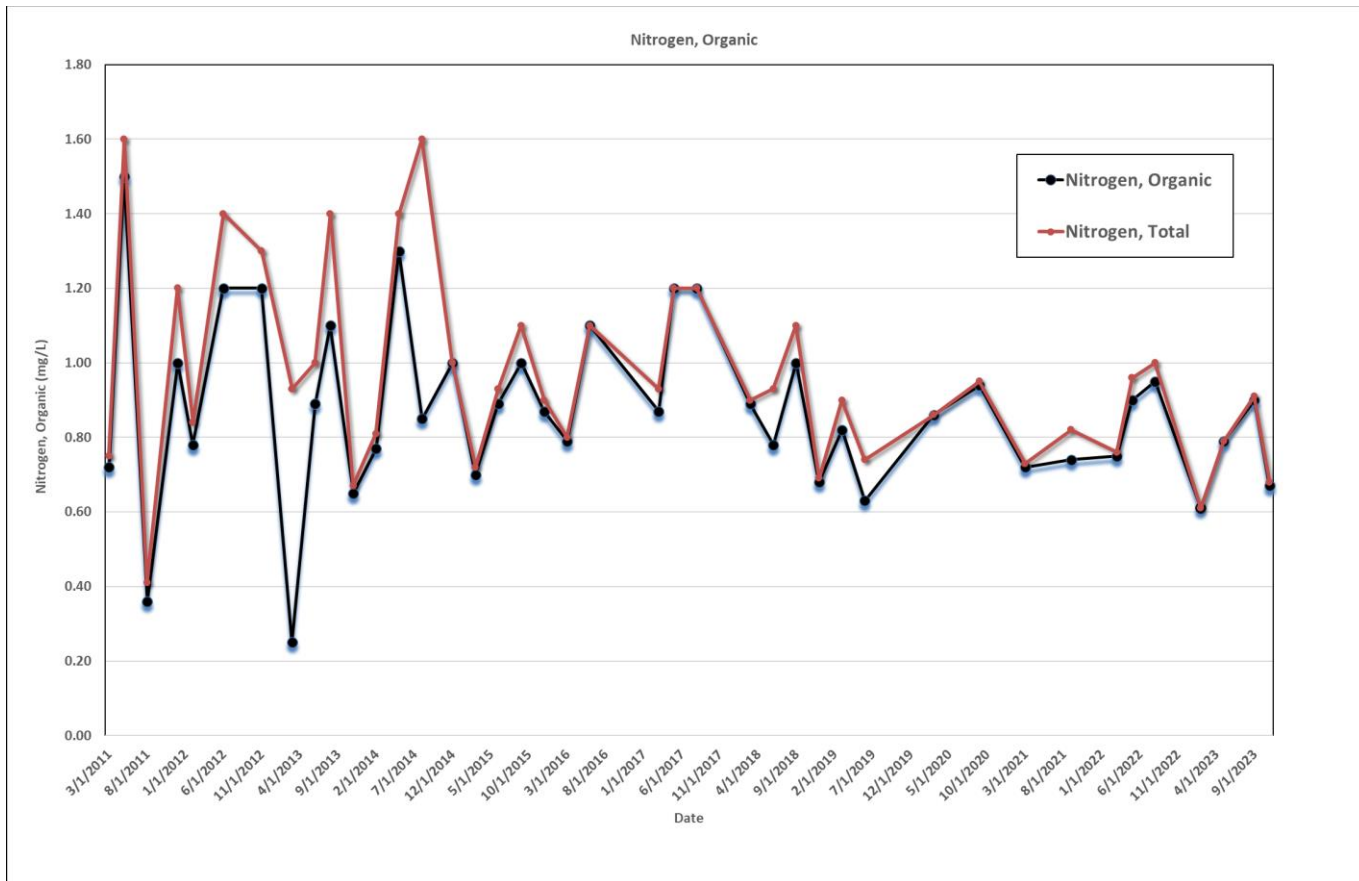
Figure 4. Total vs. Organic Nitrogen results for Lost Creek.

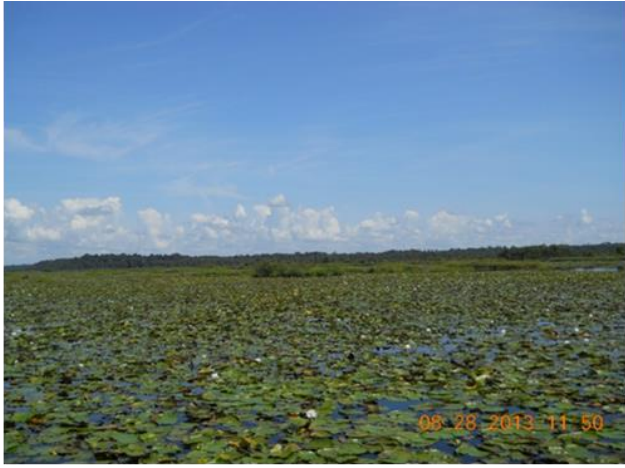
Figure 2. Station MI2 showing the variability of the plant community over time. Photos were taken in: 2013, 2017, 2018, and 2020.

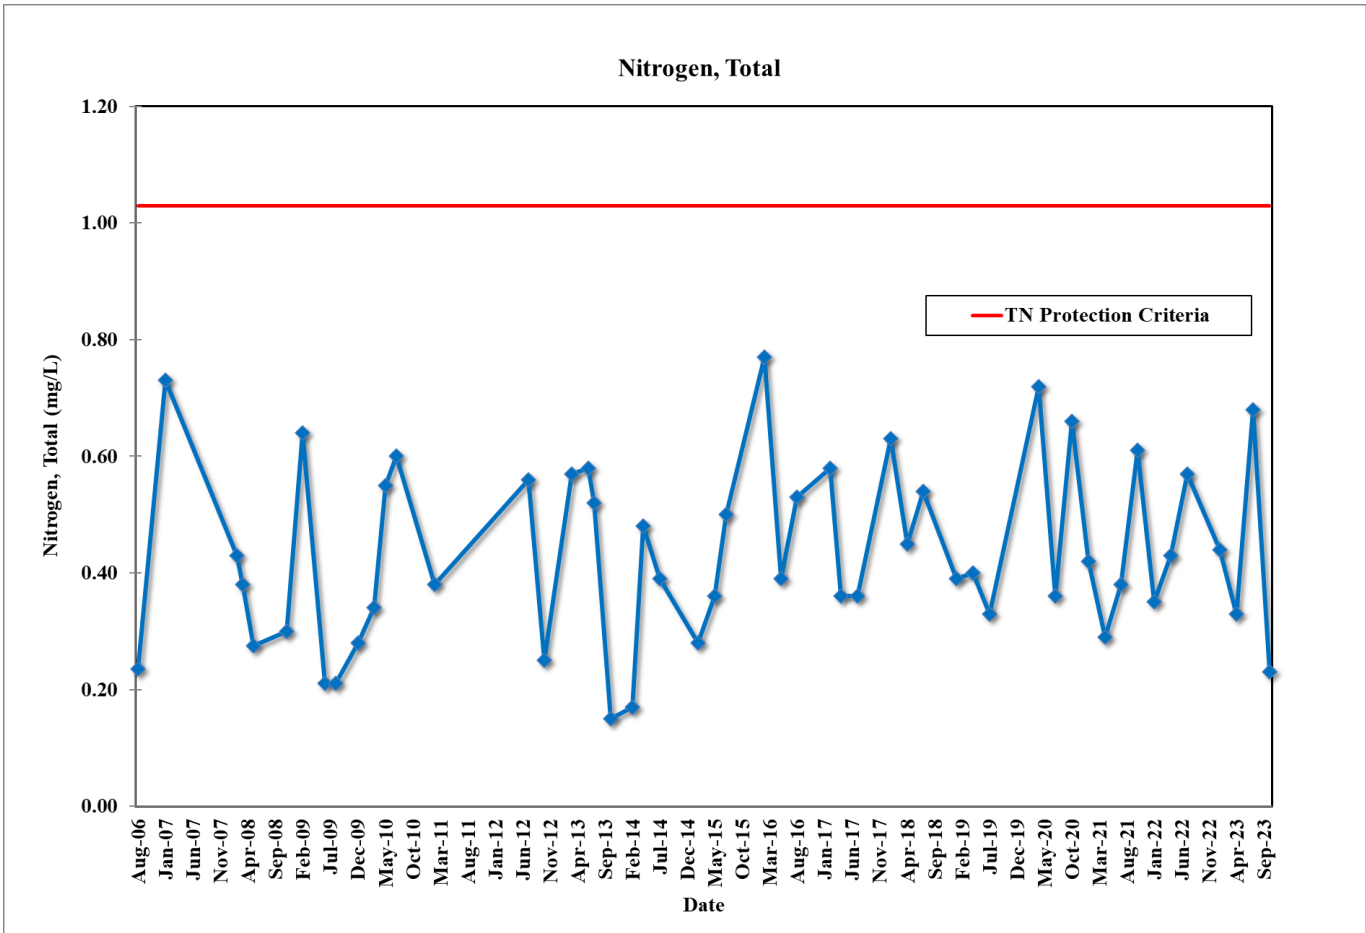
Figure 2. Total Nitrogen results for Panther Creek.

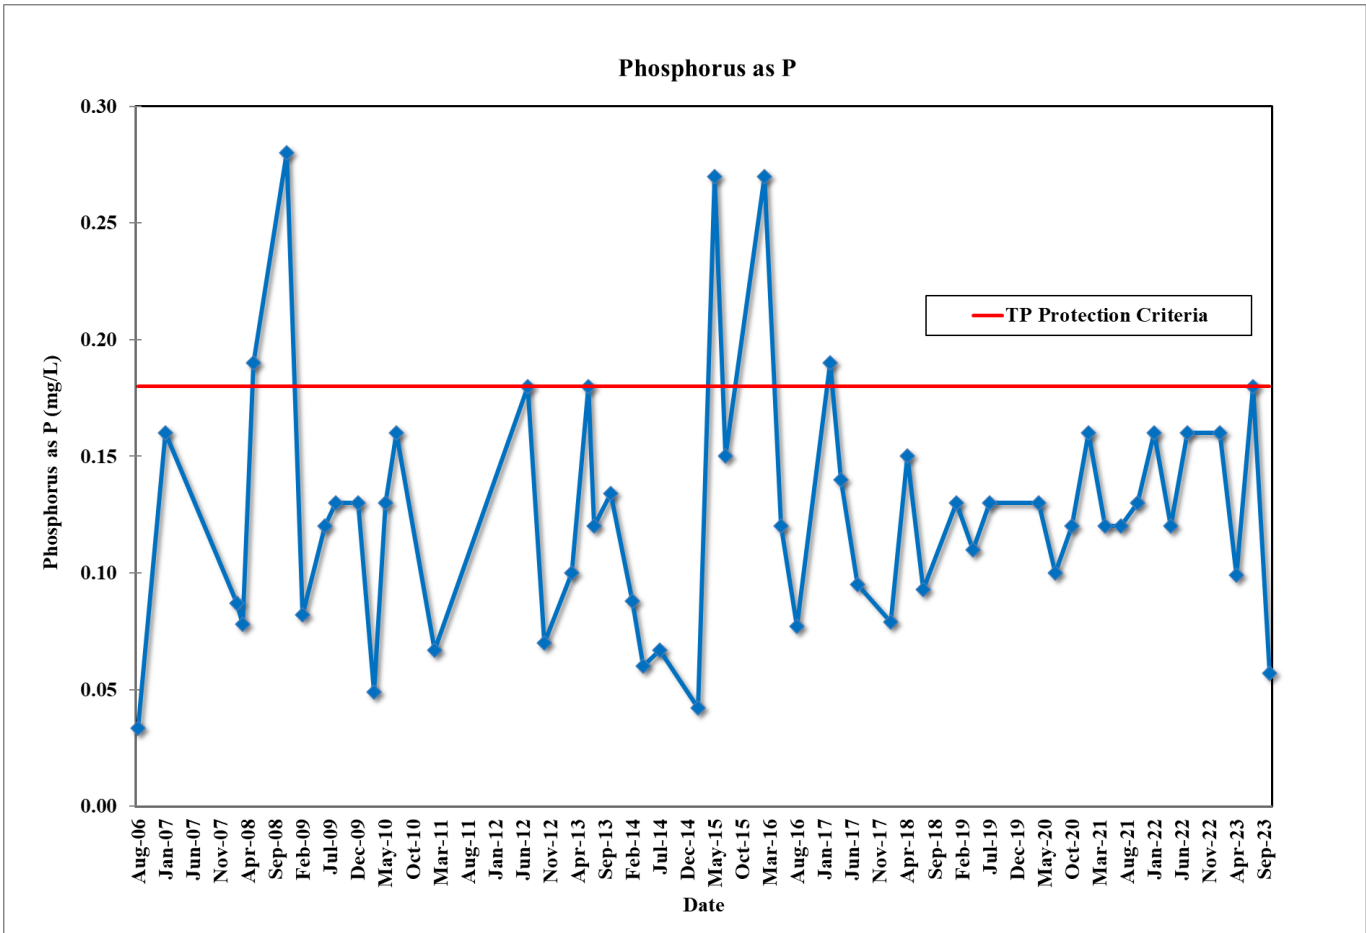
Figure 3. Total Phosphorus results for Panther Creek.

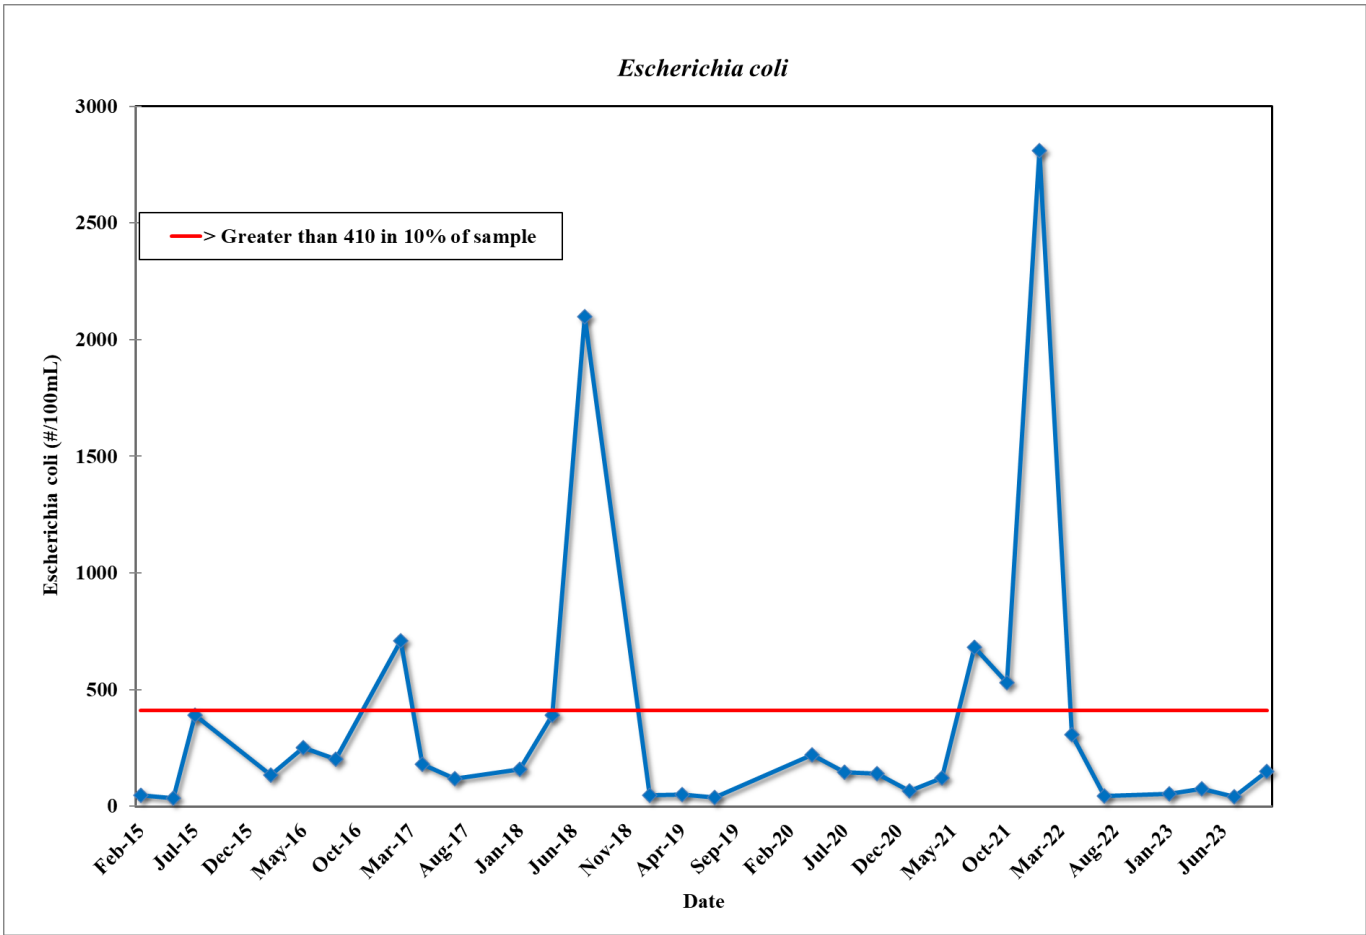
Figure 4. *E. coli* results for Panther Creek.

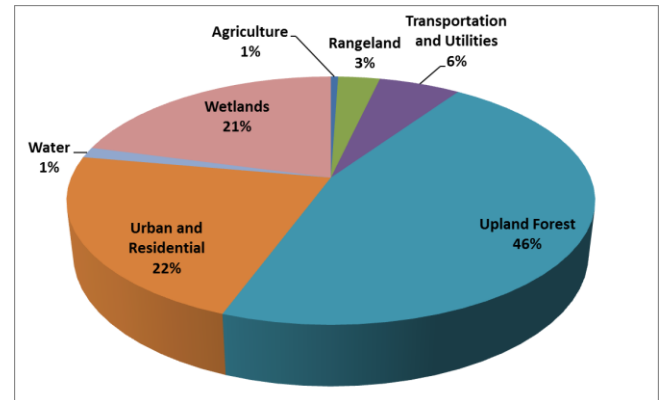
Figure 1. Lake Cascade watershed land use.

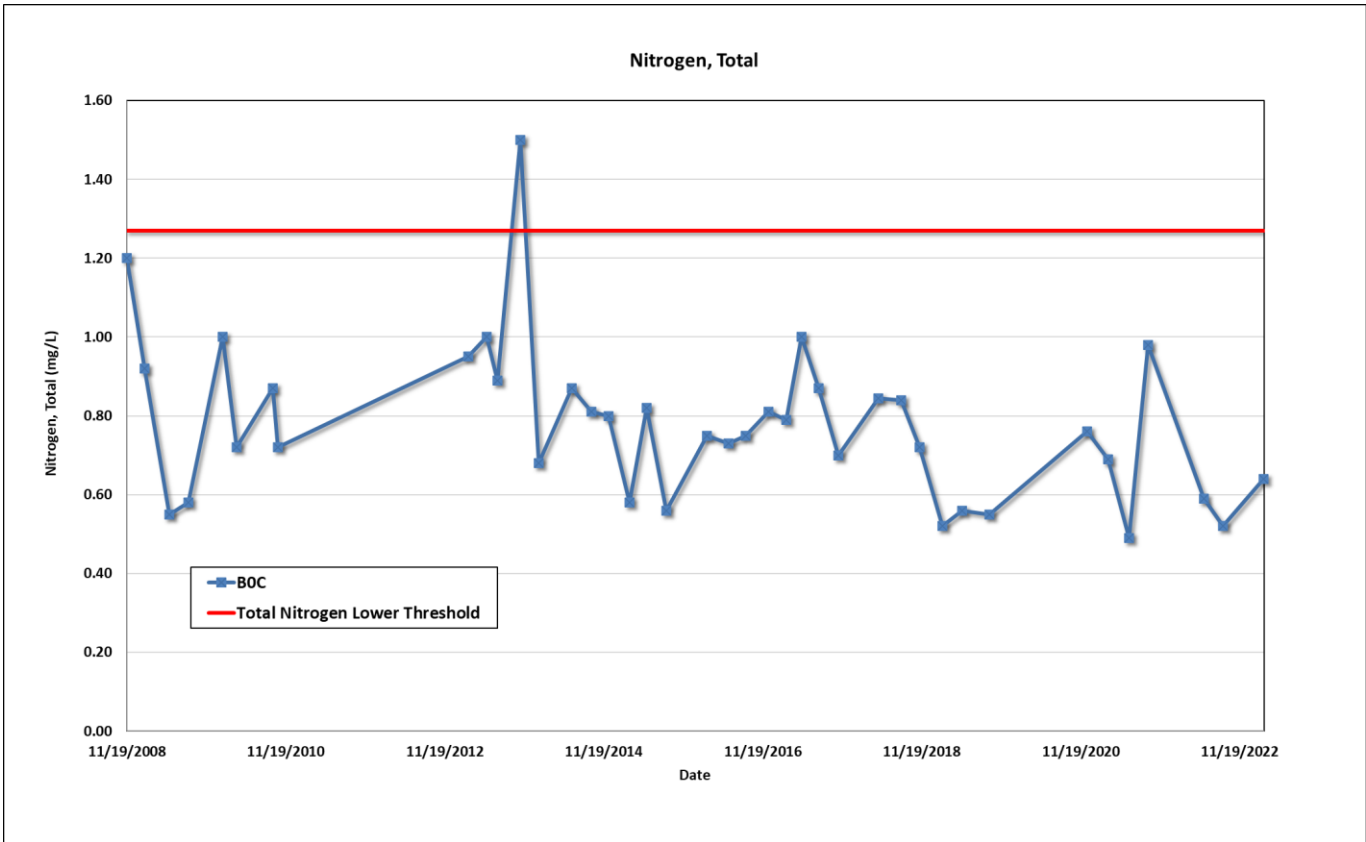
Figure 1. Total Nitrogen results for Lake Cascade.

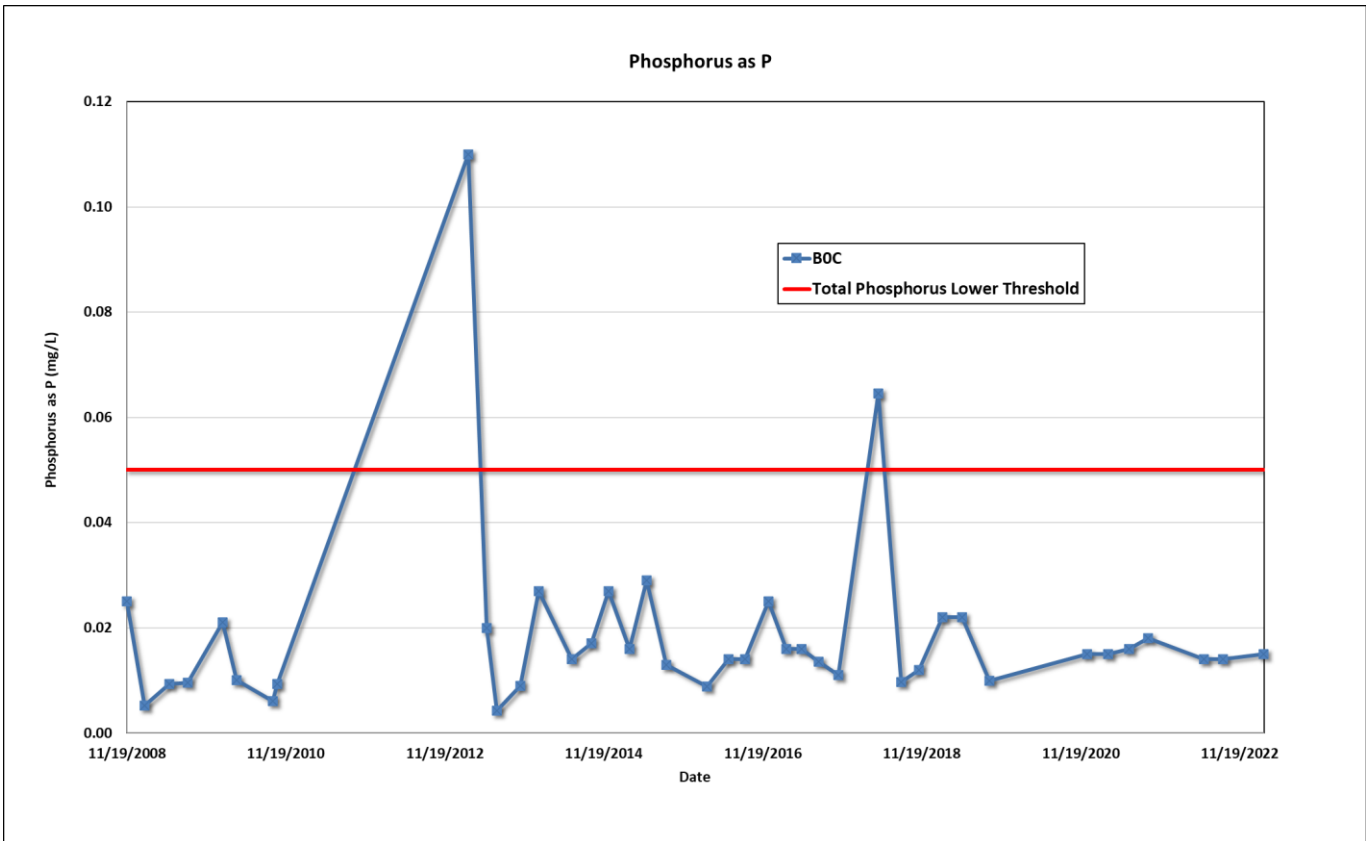
Figure 2. Total Phosphorus results for Lake Cascade.

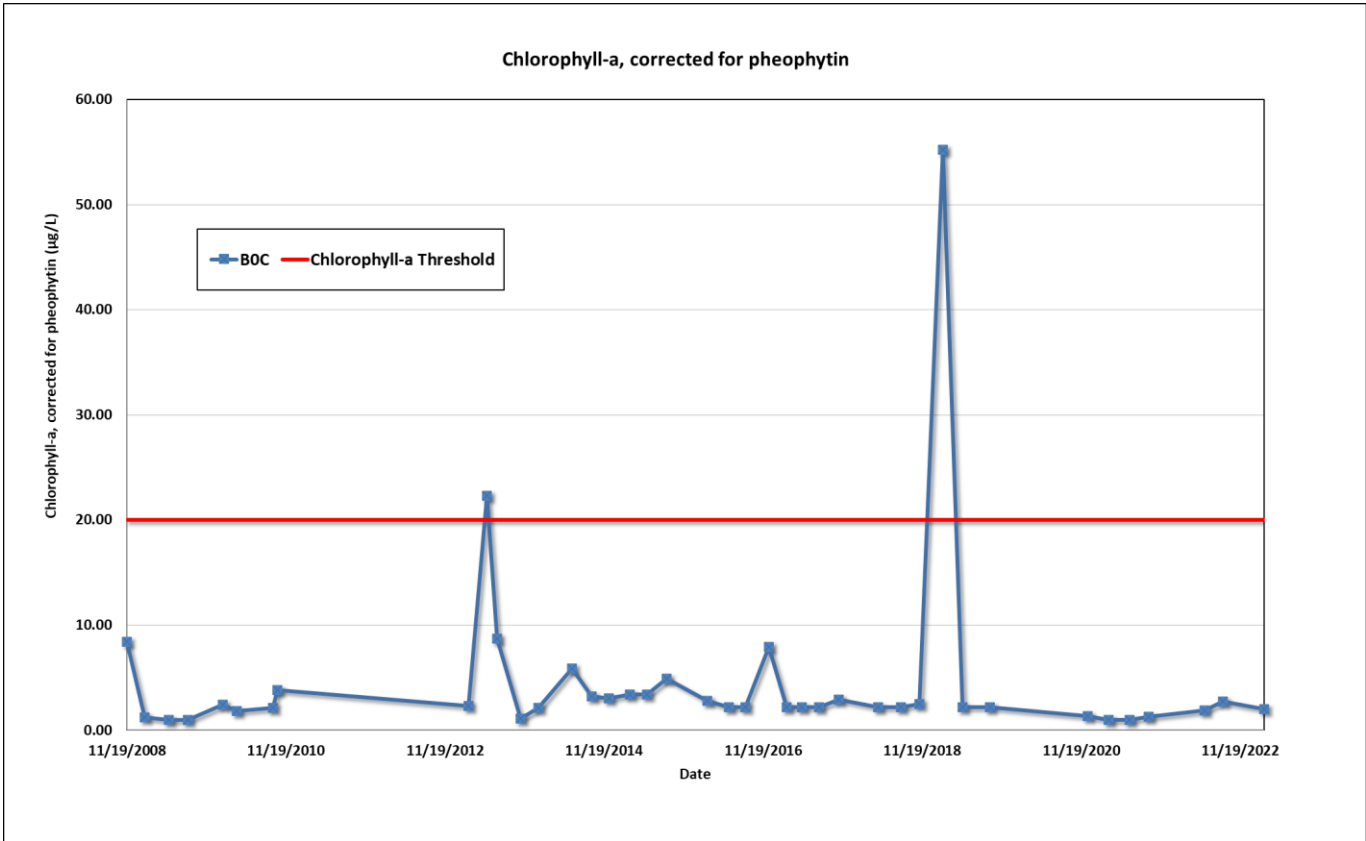
Figure 3. Chlorophyll-a results for Lake Cascade.

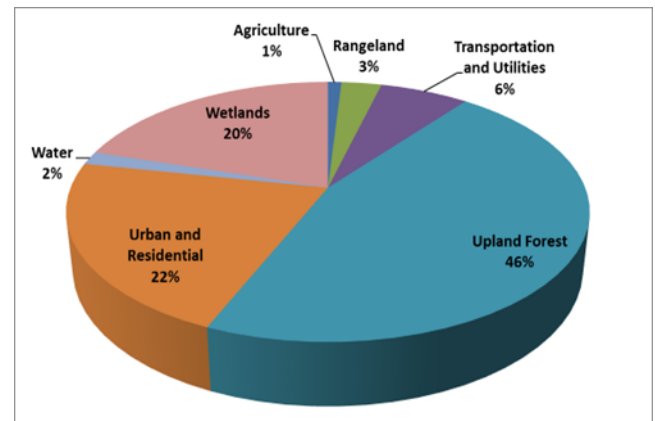
Figure 1. Lake Hiawatha watershed land use.

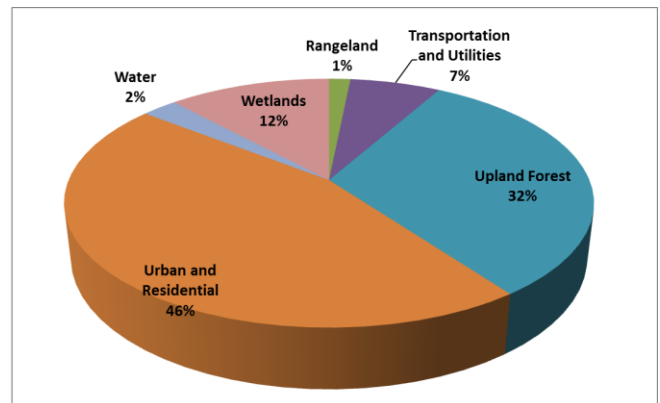
Figure 1. Lake Munson watershed land use.

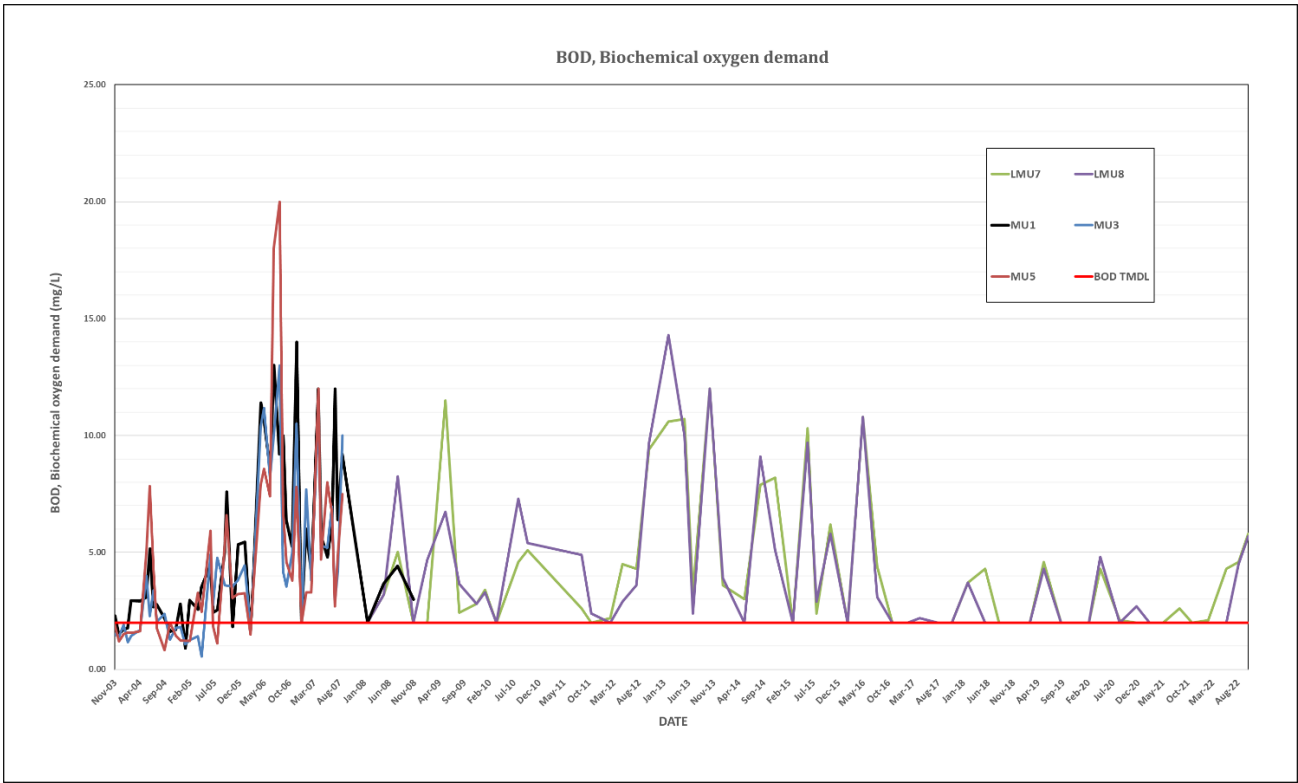
Figure 2. BOD results for Lake Munson.

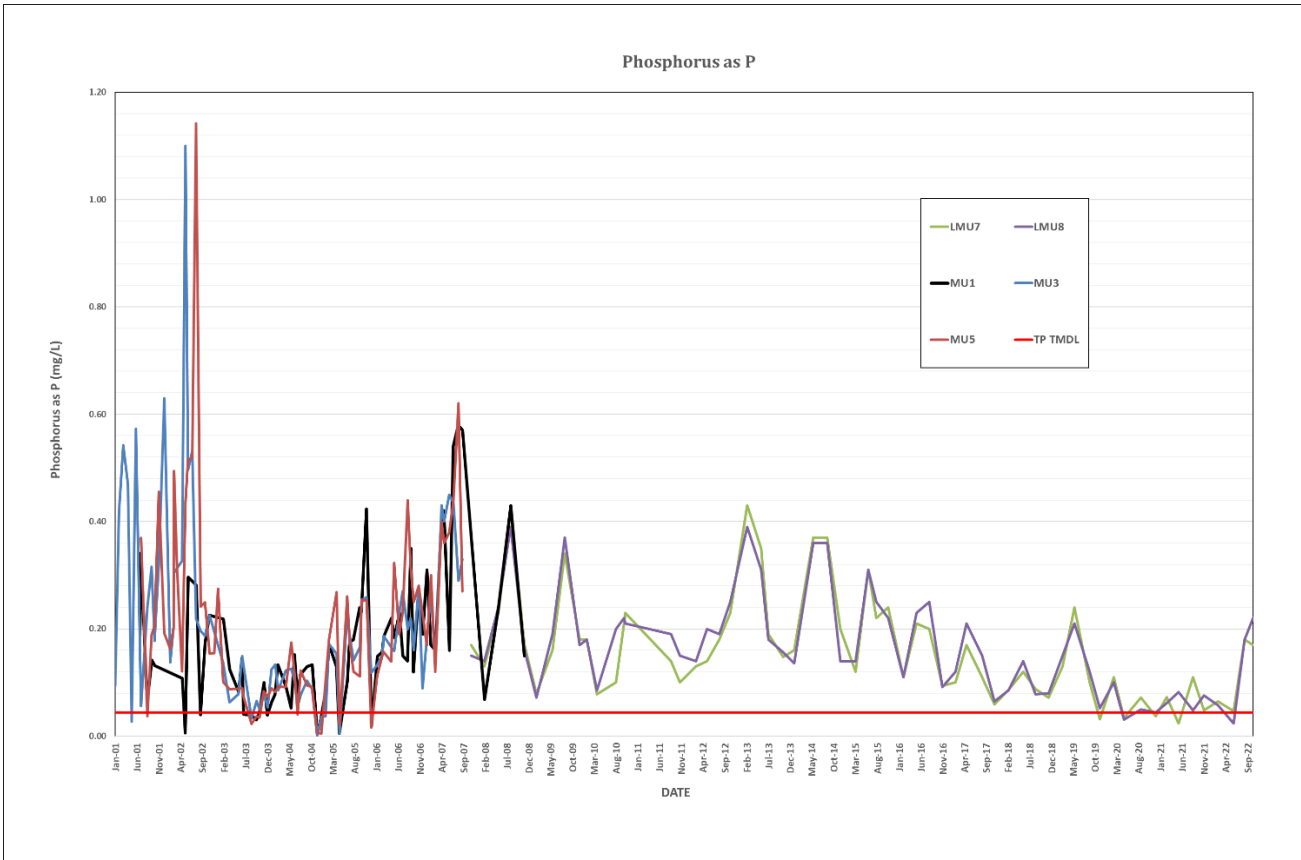
Figure 4. Total Phosphorus results for Lake Munson.

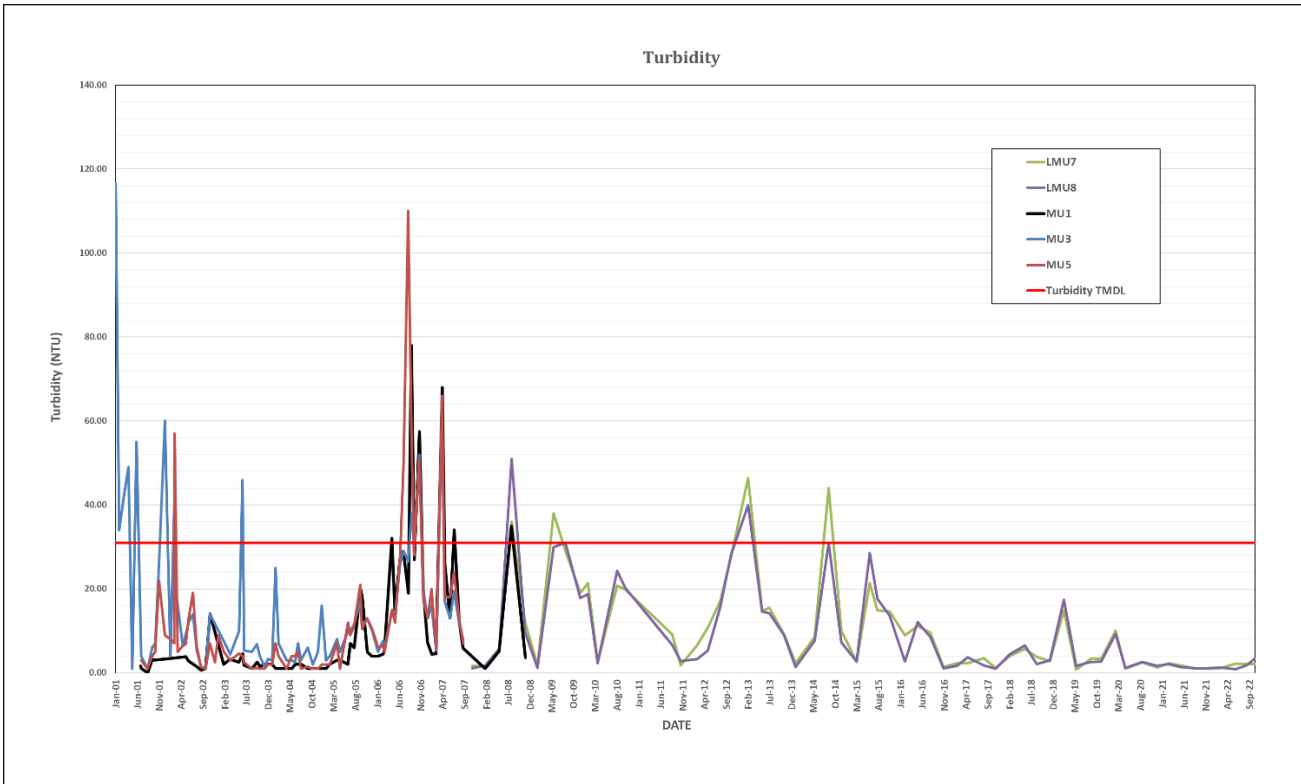
Figure 5. Turbidity results for Lake Munson.

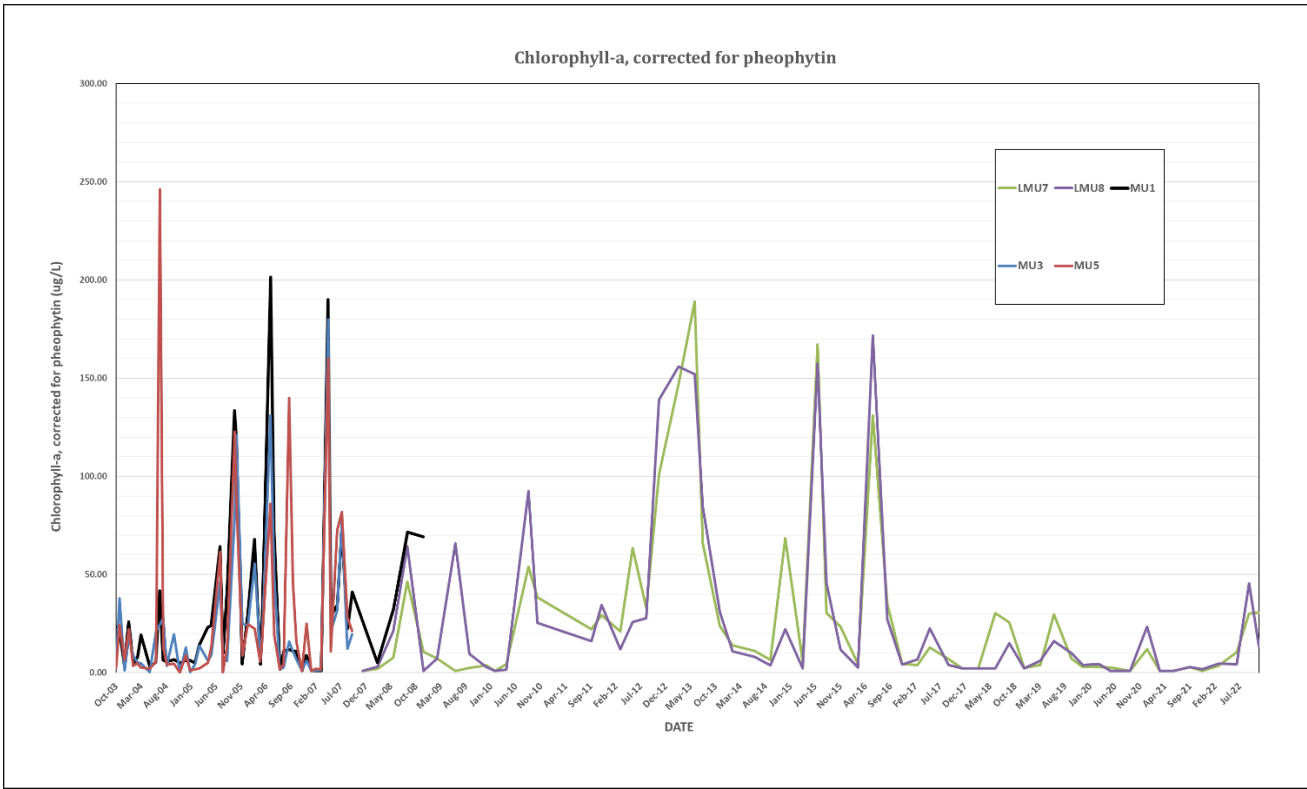
Figure 6. Chlorophyll-a results for Lake Munson.

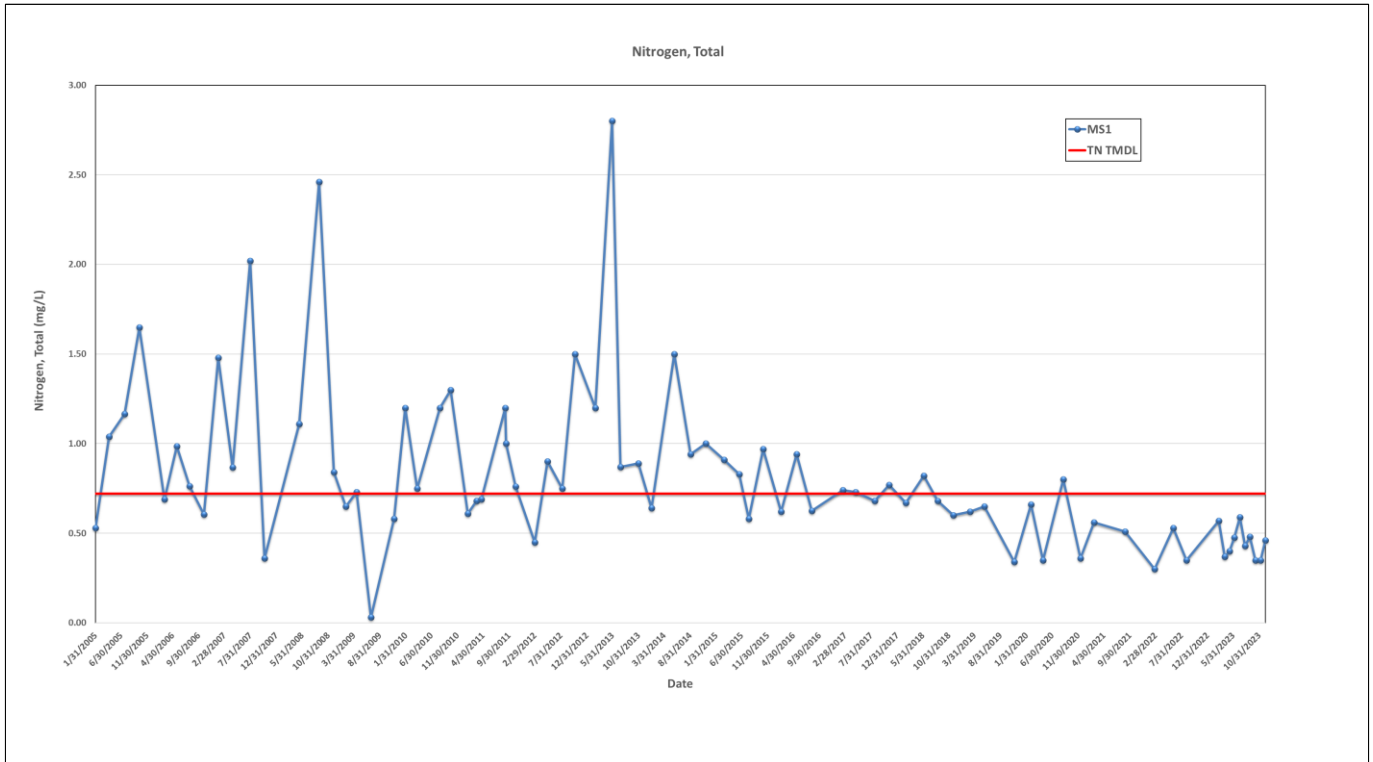
Figure 2. Total Nitrogen results for Munson Slough above the lake (Station MS1).

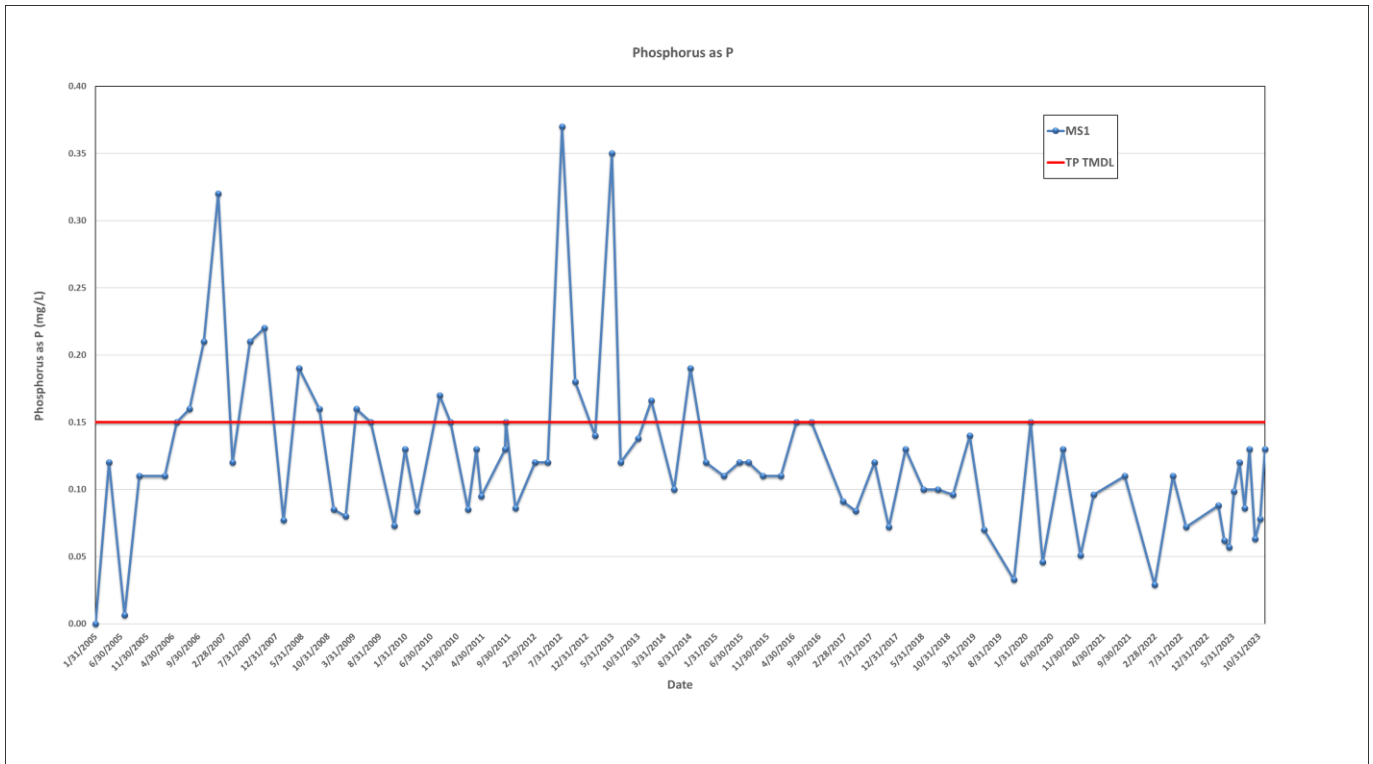
Figure 3. Total Phosphorus results for Munson Slough above the lake (Station MS1).

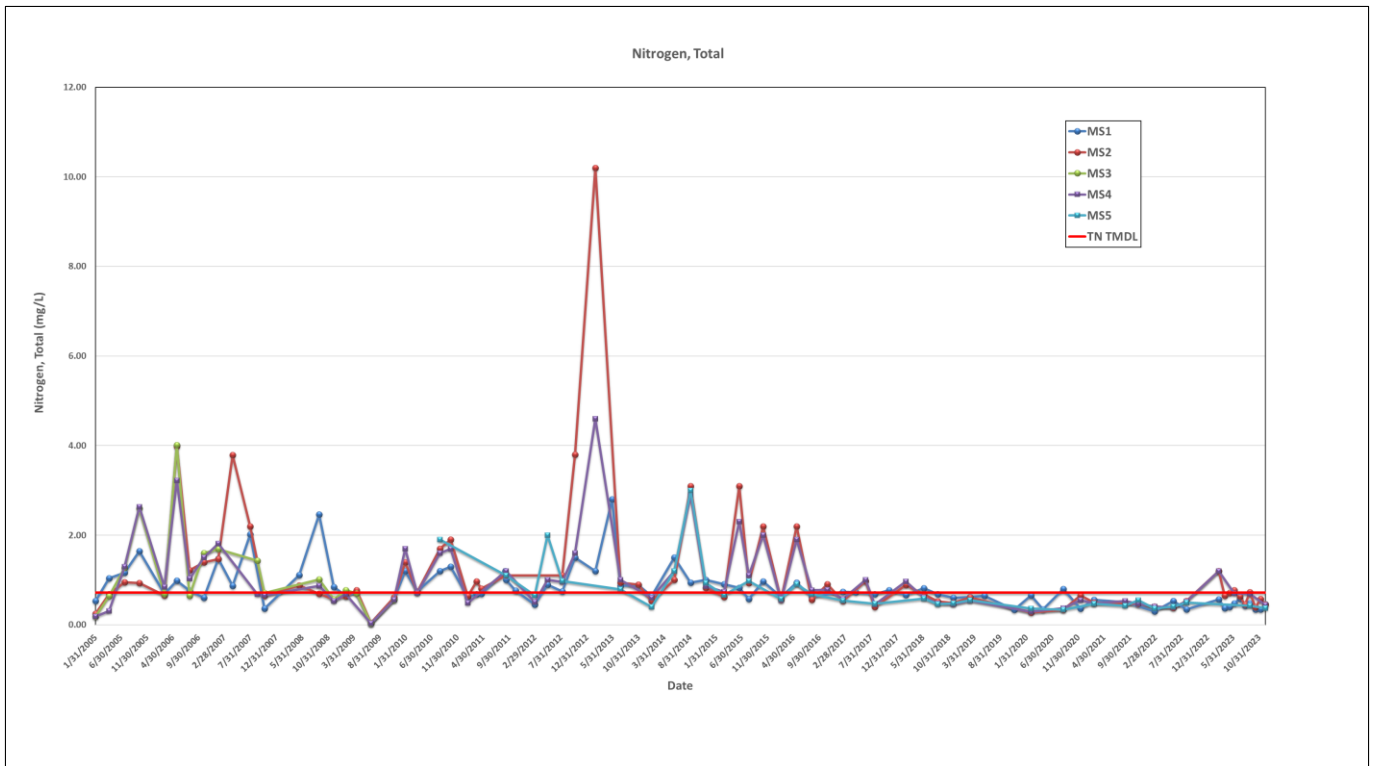
Figure 4. Total Nitrogen results for Munson Slough.

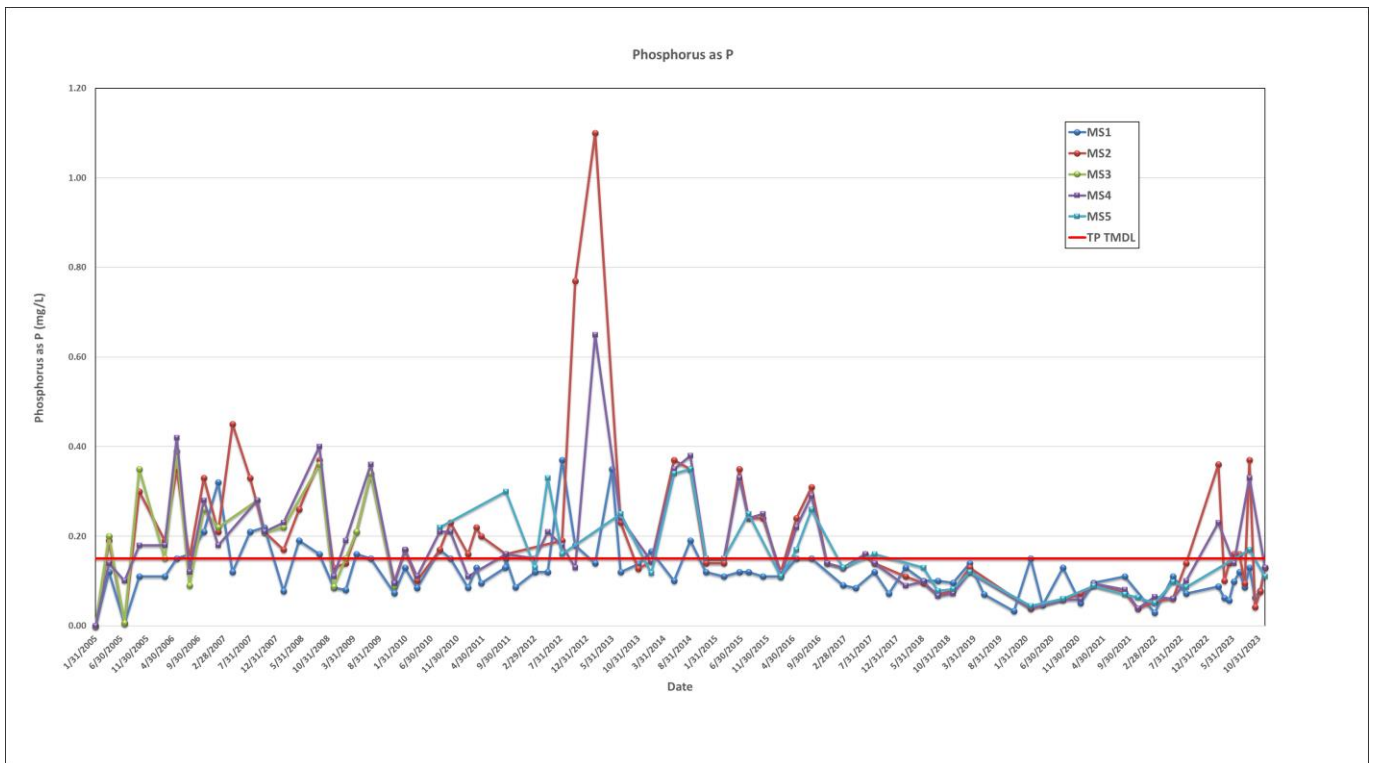
Figure 5. Total Phosphorus results for Munson Slough.

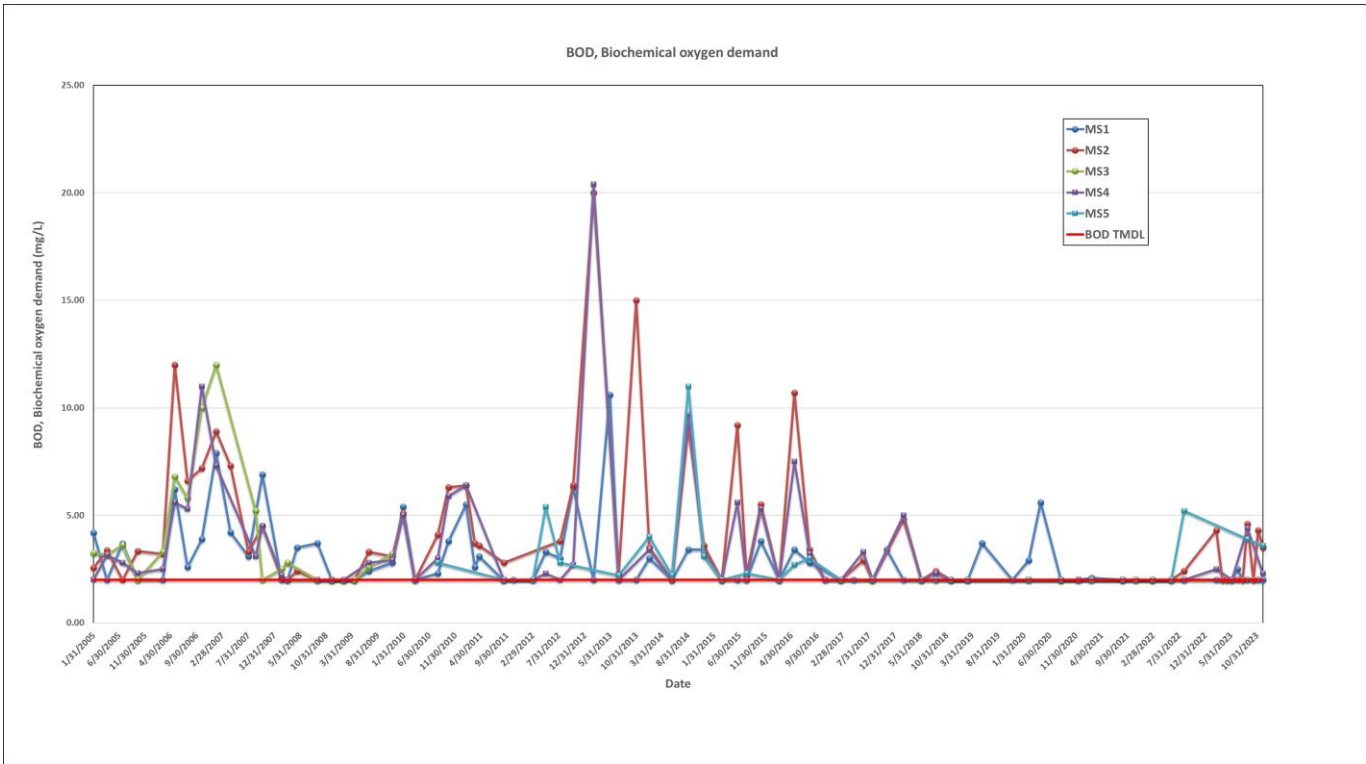
Figure 6. Biological Oxygen Demand results for Munson Slough.

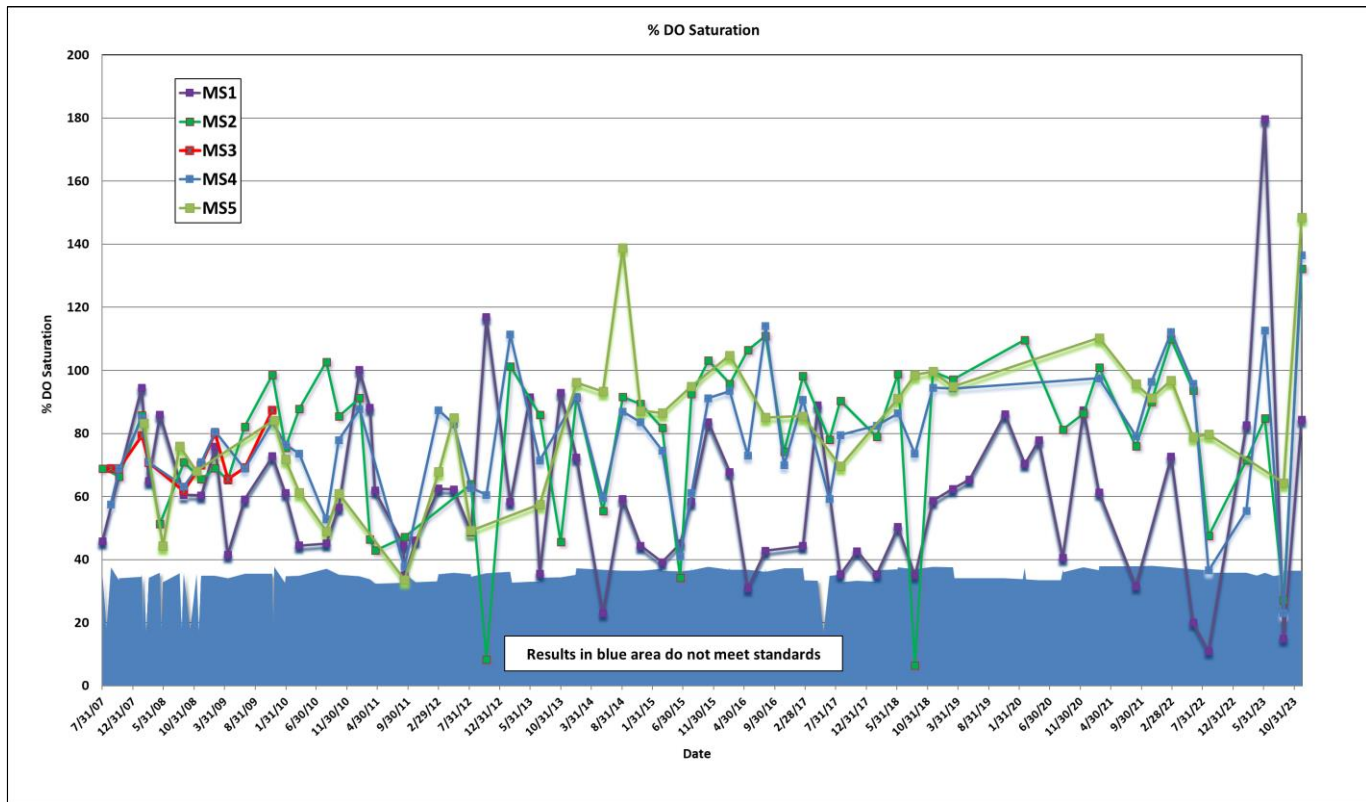
Figure 7. Dissolved Oxygen Percent Saturation results for Munson Slough.

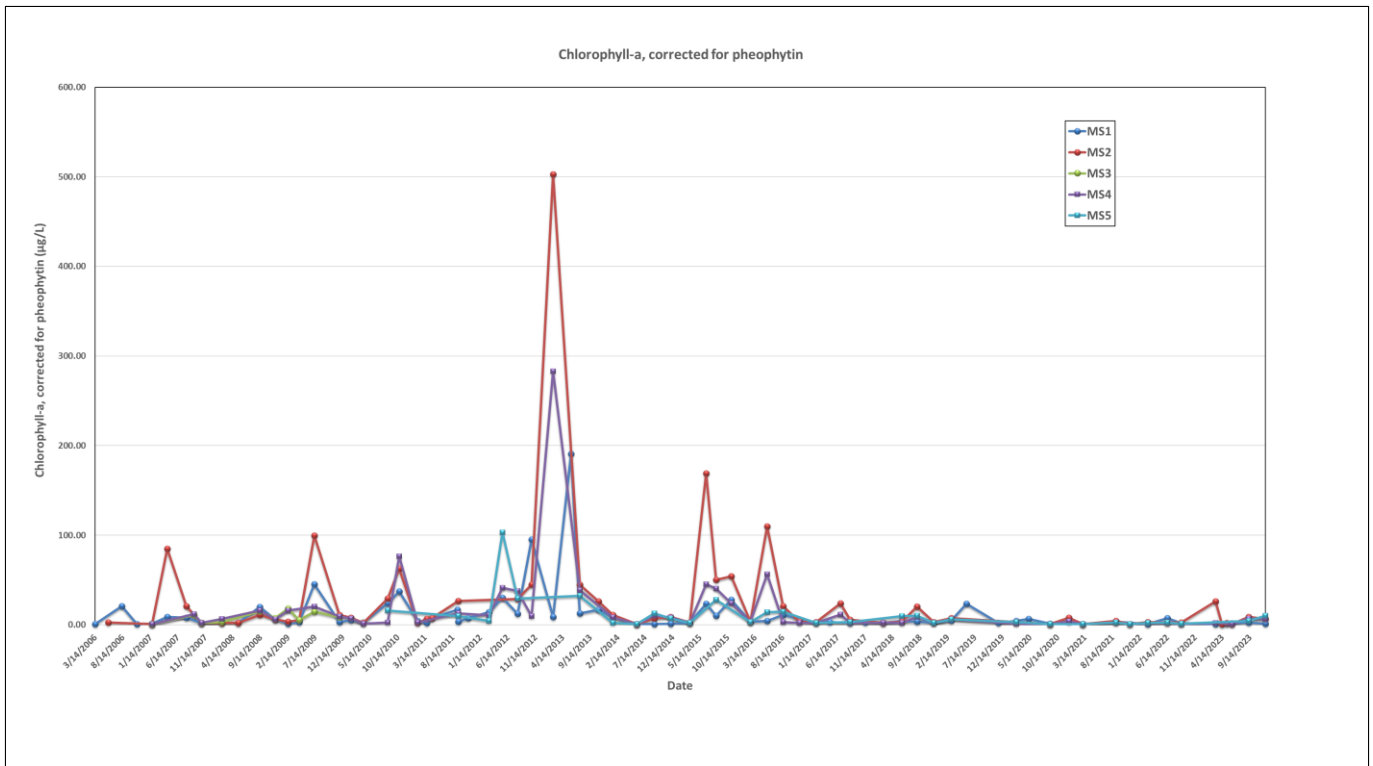
Figure 8. Chlorophyll-a results for Munson Slough.
