Water Quality Report for Selected Lakes and Streams

Leon County Public Works
Division of Engineering Services

November 2024
(Water Quality Data collected through December of 2023)

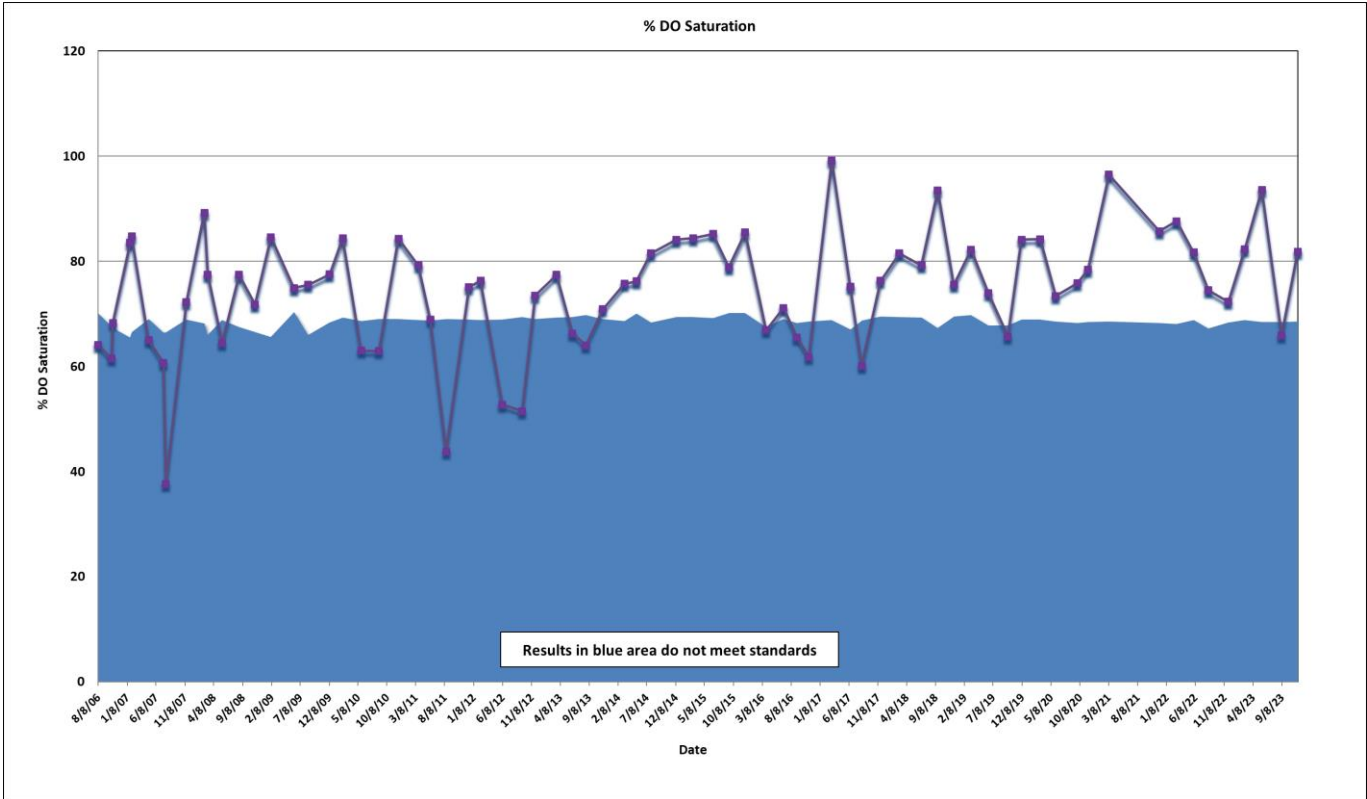
Figure 3. Dissolved Oxygen Percent Saturation results for Freeman Creek.

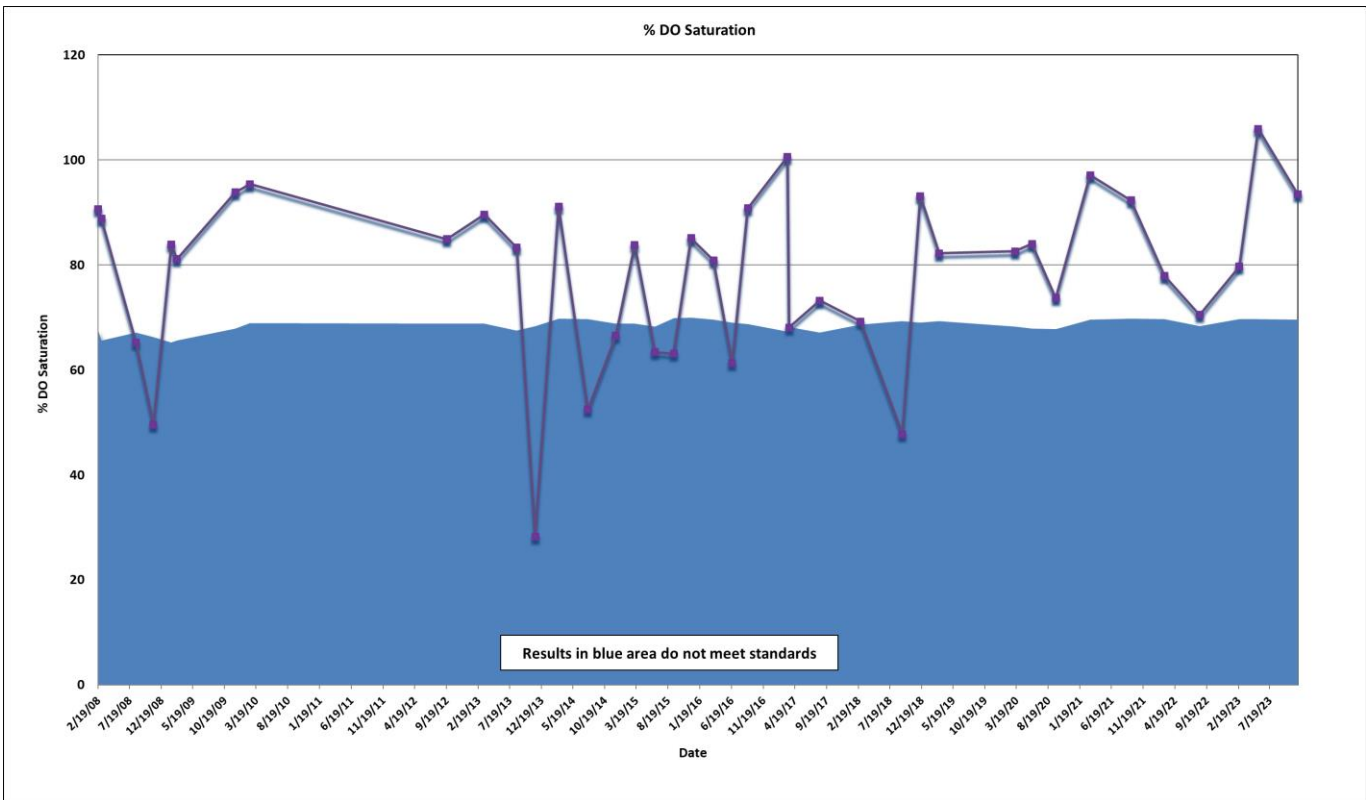
Figure 4. Dissolved Oxygen Percent Saturation results for Soapstone Creek.

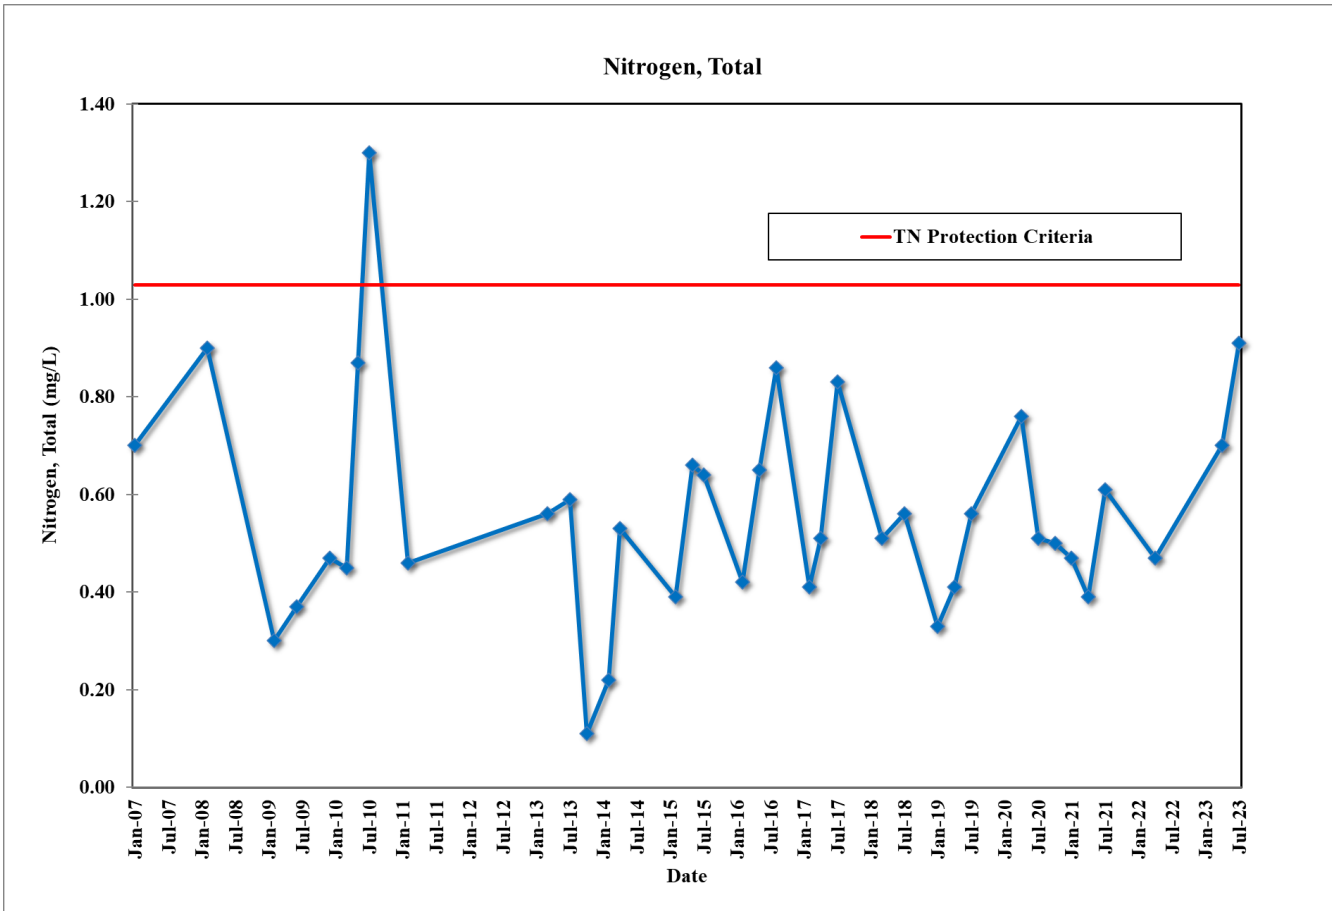
Figure 2. Total Nitrogen results for Patty Sink Drain.

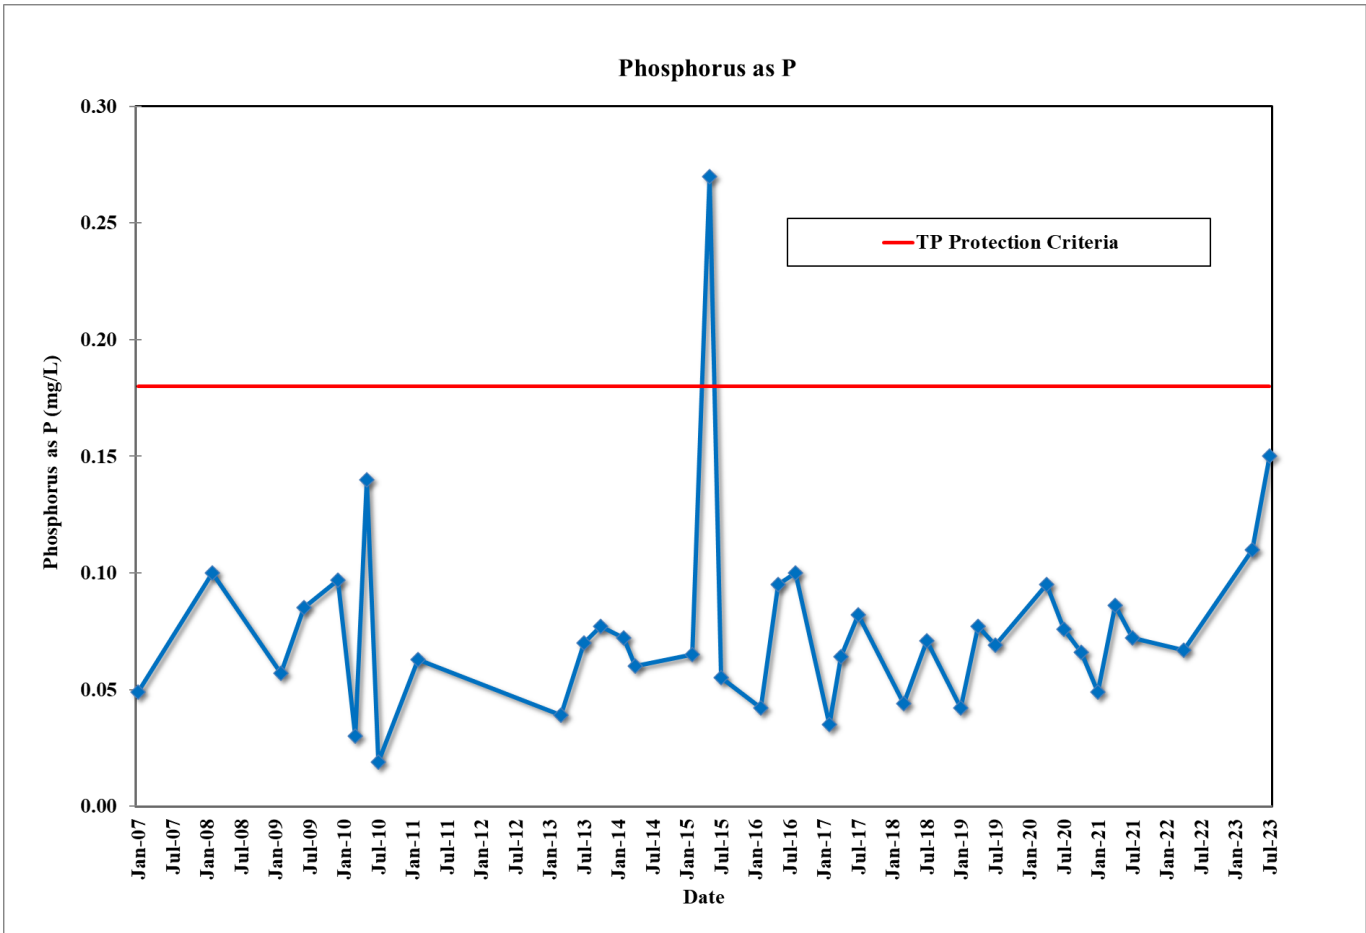
Figure 3. Total Phosphorus results for Patty Sink Drain.

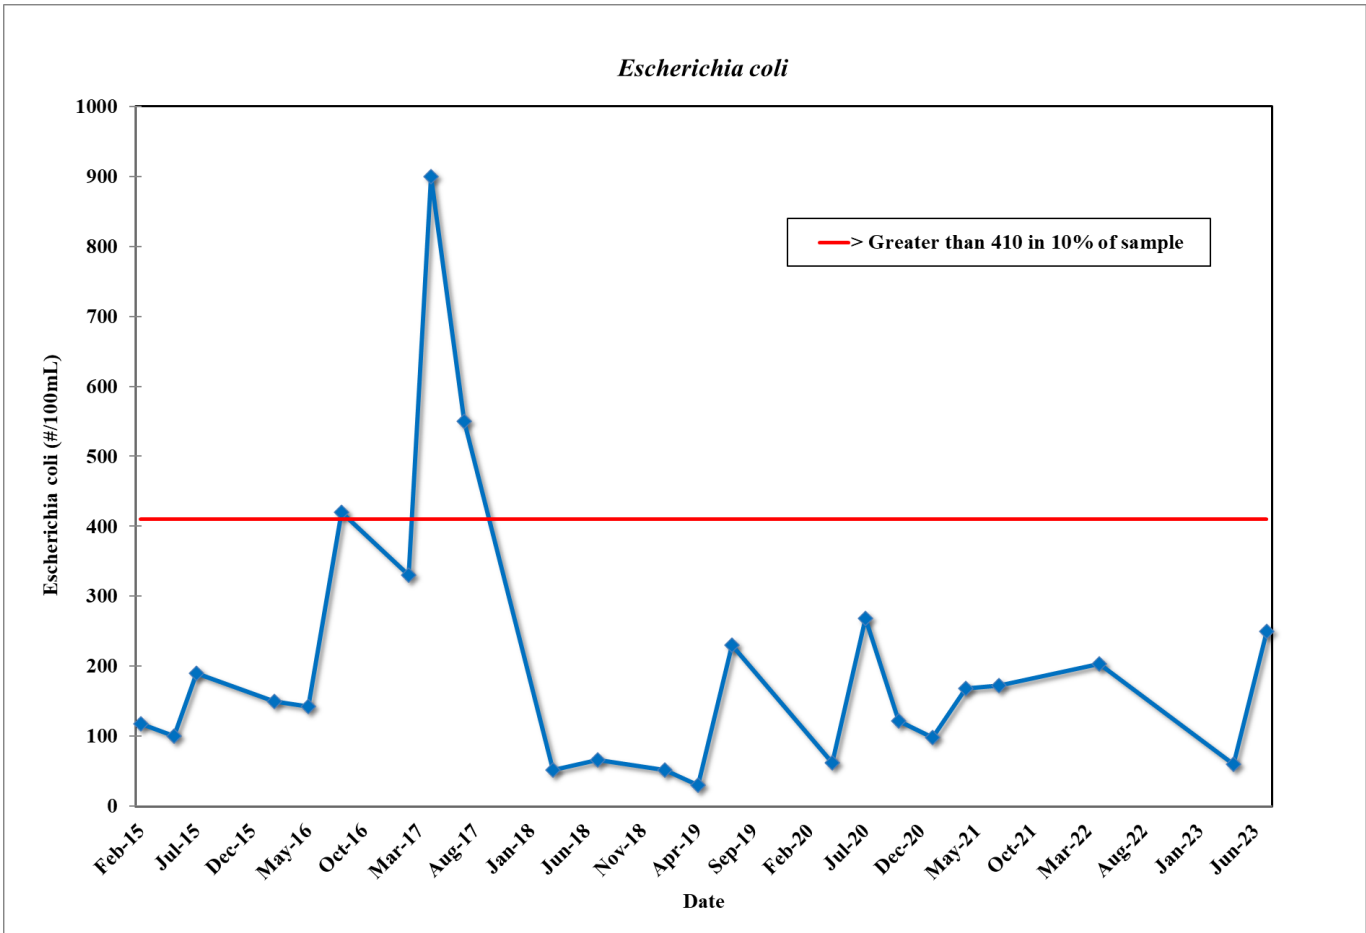
Figure 4. *E. coli* results for Patty Sink Drain.

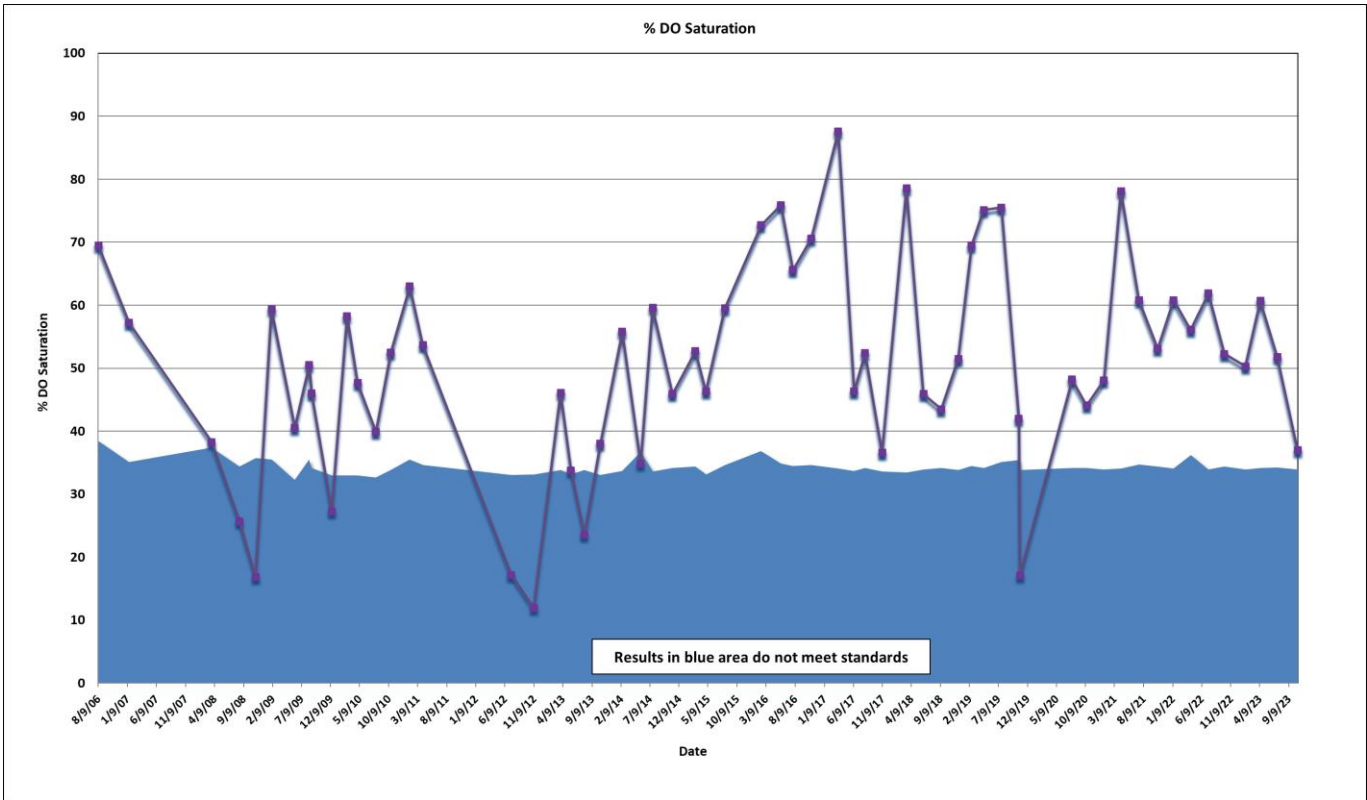
Figure 2. Dissolved Oxygen Percent Saturation results for Chicken Branch.

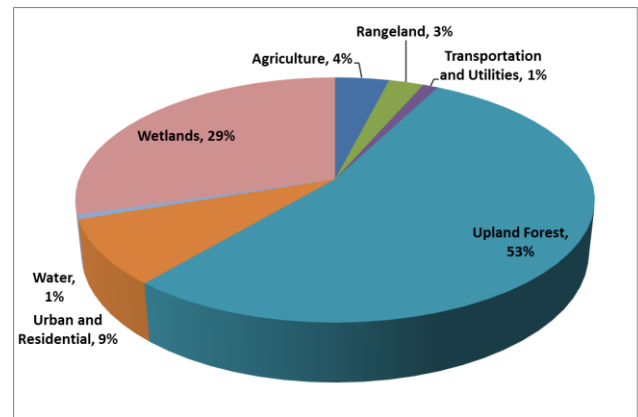
Figure 1. St. Marks watershed land use.
